Intel[®] 80303 and 80302 I/O Processors

Specification Update

May 6, 2003

Order Number: **273355-010**

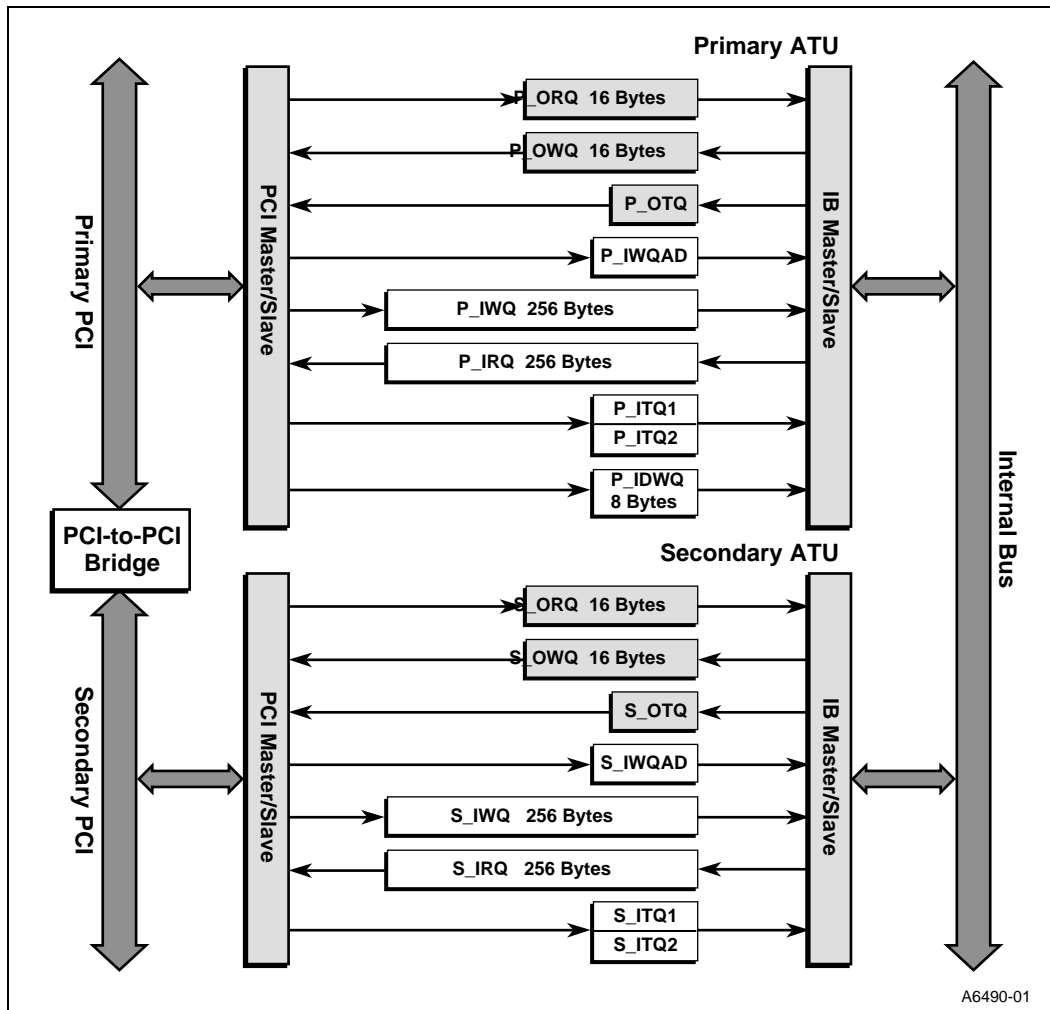
5. **Figure 15-2 on pg 15-3 did not print correctly**

Problem: Figure 15-2 on pg 15-3 did not print correctly.

Workaround: Replace Figure 15-2 with the following:

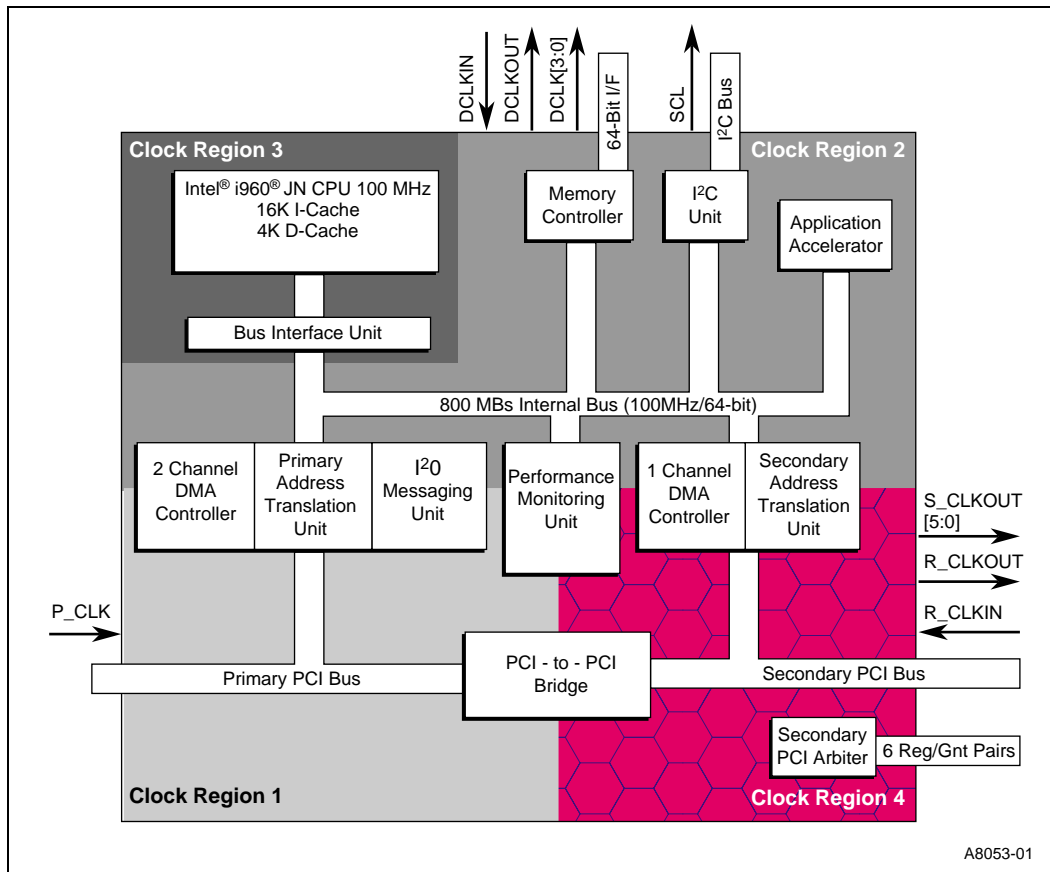
Figure 25-1. Intel® 80303 I/O Processor Clocking Regions Diagram

9. Figure 25-1 on pg 25-1 has incorrect data

Workaround: Replace Figure 25-1 with the following:

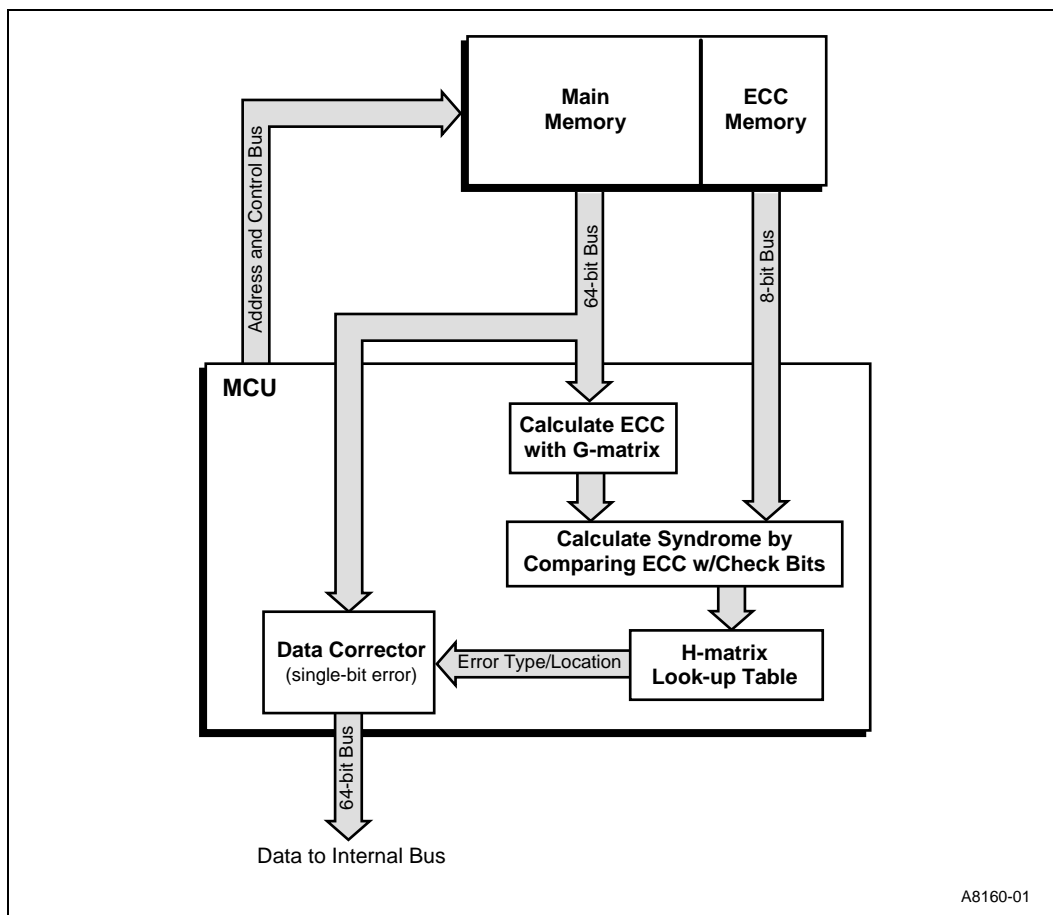
Figure 13-16. ECC Read Data Flow

Figure 13-16 shows how the data flows through the ECC hardware for a read transaction.

Workaround: Replace Table 13-13 with the following and, add the adjacent paragraph with “new” Figure 13-16:
