Subject: CENTER CONSOLE LID WILL NOT STAY CLOSED	Bulletin No: 09-033/06
	Last Issued: 7/21/2006

2006 MX-5

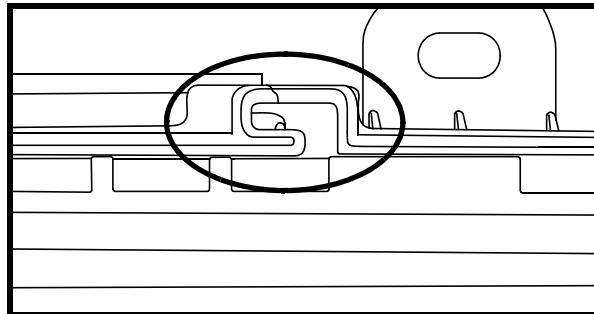
GUIDE TAB SHOWN ENGAGED

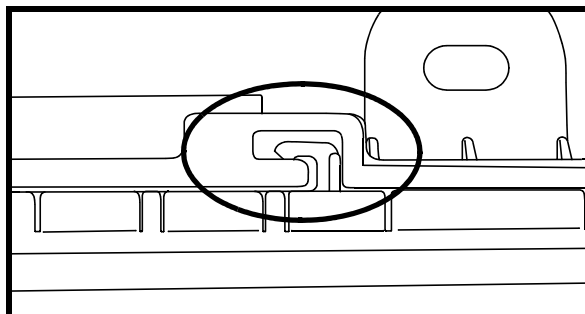
1653c

GUIDE TAB SHOWN DISENGAGED

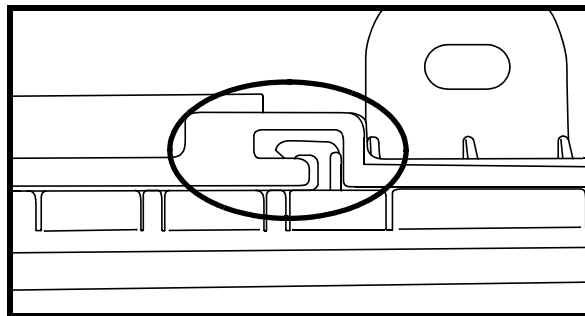
GUIDE TAB SHOWN DISENGAGED

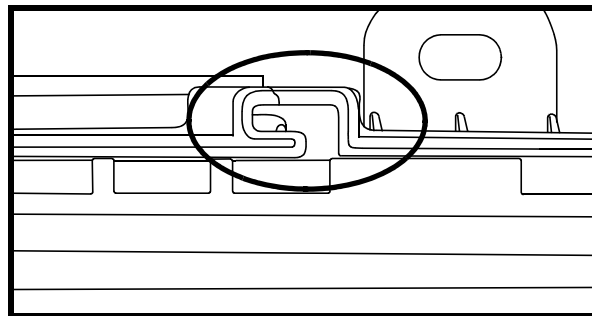
1653h

GUIDE TAB SHOWN ENGAGED
