TMS320C6201
Digital Signal Processor
Silicon Errata

SPRZ153
November 2000

This document describes the silicon updates to the functional specifications for the TMS320C6201 silicon releases 3.1, 3.0, 2.1, and 2.0.

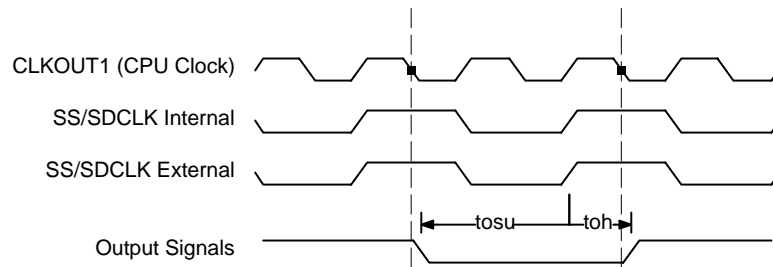
Figure 4. Write Example – Desired Behavior

The desired relationship is described in the TMS320C6201B data sheet (SPRS051) and is illustrated in Figure 4 and Figure 6. However, in the case where SDCLK/SSCLK becomes inverted (Figure 5 and Figure 7), control signals only have 1/2 CPU clock of setup to the next SDCLK/SSCLK rising rather than 3/2 CPU clock of setup. This has two negative effects to interface timing to external synchronous RAMs.

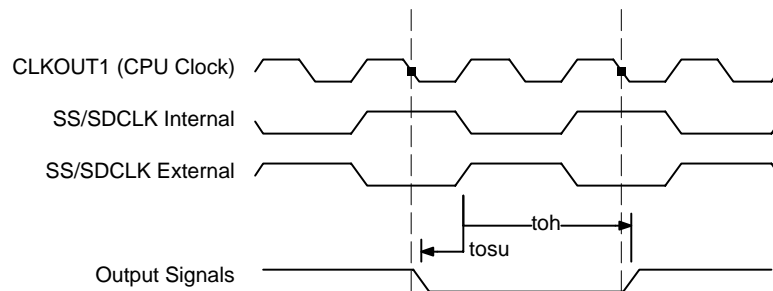
Figure 5. Write Example – Failing Behavior

A speedpath in the device causes SDCLK and SSCLK to start up 180 degrees out-of-phase (effectively inverted) from the desired waveform. Normally, EMIF outputs are delayed 1/2 CPU clock from the rising edge of SDCLK/SSCLK to give it adequate hold time while maintaining more than adequate setup times.

1. On writes, setup time to RAMs for control signals and write data is reduced by 1 CPU cycle.

- For prototypes, raising the core supply to 1.9 – 2.1 V corrects this problem. This is not recommended in boards shipped to customers, since the manufacturing process is not designed to be reliable outside the normal operating range. This option allows the user to verify current board designs at all valid frequency ranges.

- Reduce the operating frequency of the TMS320C6201B until SSCLK/SDCLK has the desired relationship. Typically, this occurs at 175 MHz across the range of recommended operating conditions.

- Since SSCLK and SDCLK are inverted externally relative to each other by design, these signals can be swapped on external memory interfaces to correct the problem (SSCLK to SDRAM and SDCLK to SBSRAM). This will cause invalid operation at frequencies below 175 MHz and will not work with future silicon revisions.

- If CLKOUT2 is used as an SDRAM clock, follow all the workarounds for SDCLK.

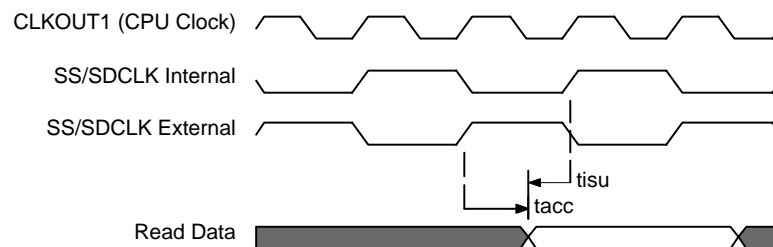
**Figure 7. Read Example – Failing Behavior**

- On SBSRAM/SDRAM reads, data will be sampled on the falling edge before the rising edge that would be expected. In this case, the input setup time for data at the C62x™ is reduced by 1 CPU cycle. Note that this case can be compounded with Case 1. The control signals could be latched one SSCLK/SDCLK cycle (2 CPU cycles) late by the memories. Thus, the setup could be reduced by up to 3 CPU cycles and be more than an entire SSCLK/SDCLK late.

CLKOUT2 is also affected by this speedpath bug and is 180 degrees out-of-phase. It behaves in the same way as SDCLK. (Internal reference number C601307)
