MJ-1101 Service Manual Addendum

Supplement to the Troubleshooting Section

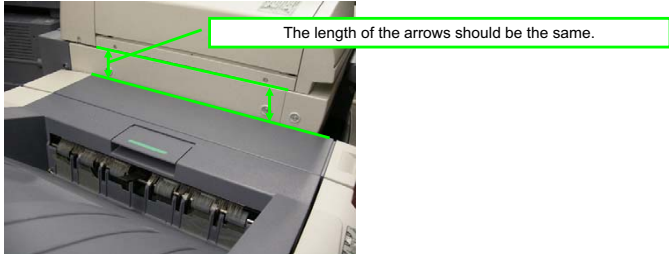
Error code	Phenomenon	Possible cause	Items to confirm / Countermeasures	Precautions / Remarks
EA20	<ul style="list-style-type: none"> - Paper jams at the entrance section of the Finisher (or the Hole Punch Unit) - Folded paper edge - Paper jams C2in the buffer tray section - C2Paper exit problems on the finishing tray 	<p>1. Improper installation height (Paper is not properly transported from the equipment to the Finisher if each height is improper.)</p>	<p>A. Confirm that the Finisher is installed horizontally (the height of its front side and that of its rear side are the same).</p>

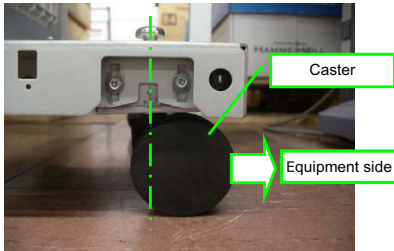
<ul style="list-style-type: none"> - Note that the height should be different between the cases when the Finisher is installed in e-STUDIO281c/351c/451c and when installed in e-STUDIO352/452 or e-STUDIO2500c/3500c/3510c. - Confirm the height every time you move the equipment.
			<p>B. To keep the installation height of the Finisher stable, it is preferable that the casters are faced to the equipment side.</p>

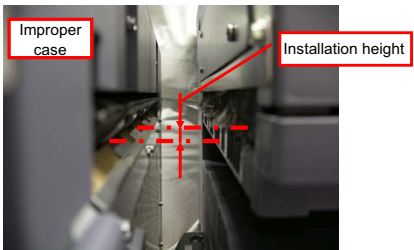
<p>C. When installing the Finisher in the equipment, make sure that the height of the Finisher is proper. If it is not, the Bridge Unit exit Mylar may be deformed, and thus the deformed Mylar may obstruct the paper transport path.</p>

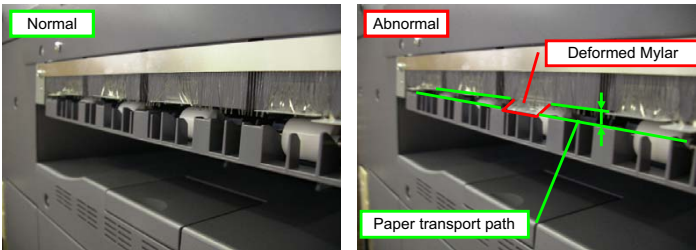
<p>2. Bridge Unit exit Mylar deformed</p>	<p>Check if the Mylar attached to the exit of the Bridge Unit is deformed and obstructing the paper transport path. Correct it if deformed.</p>	<ul style="list-style-type: none"> - Note that the height should be different between the cases when the Finisher is installed in e-STUDIO281c/351c/451c and when installed in e-STUDIO352/452 or e-STUDIO2500c/3500c/3510c.

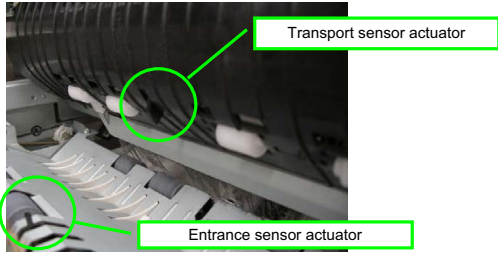
Error code	Phenomenon	Possible cause	Items to confirm / Countermeasures	Precautions / Remarks
EA20	<p>- Paper jams at the entrance section of the Finisher (or the Hole Punch Unit)</p> <p>- Folded paper edge</p> <p>- Paper jams C2in the buffer tray section</p> <p>- C2Paper exit problems on the finishing tray</p>	<p>5. False operation of the entrance sensor or the transport sensor</p> <p>(An error may occur when the entrance sensor or the transport sensor does not perform proper detection.)</p>	<p>B. Check if the actuators of the entrance sensor and the transport sensor are operating smoothly. If they are not, remove the actuator and check if there is any paper dust or foreign matter between the shaft and the hole. Clean if there is.</p>

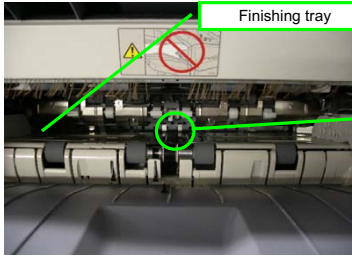
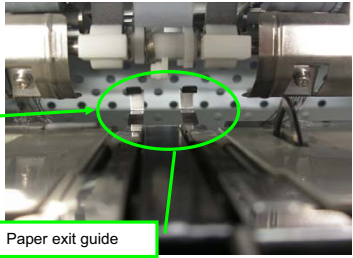
<p>6. False operation of the paper exit guide</p> <p>(An error may occur when the paper exit guide is not operating properly because paper may remain on the finishing tray or not exit properly during sort or stapling exit.)</p>	<p>Replace SPG-SFFD-SUPT-SF (6LB090140) if the paper exit guide is not operating properly.</p>

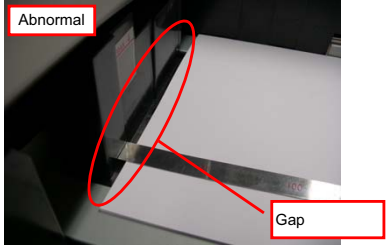
<p>7. Paper not placed properly in the drawer</p> <p>(Paper may be skewed if there is extra gap between the paper and the side wall in the drawer and thus may cause a jam on the Finisher transport path.)</p>

<p>Be sure to lock the side wall.</p>

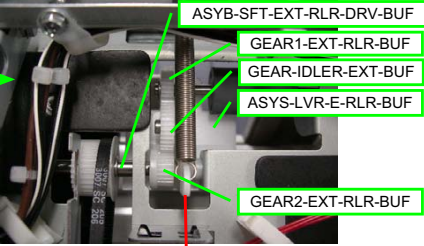
Error code	Phenomenon	Possible cause	Items to confirm / Countermeasures	Precautions / Remarks
EA20	<ul style="list-style-type: none"> - Paper jams at the entrance section of the Finisher (or the Hole Punch Unit) - Folded paper edge - Paper jams C2in the buffer tray section - C2Paper exit problems on the finishing tray 	8. Drive not transmitted from the gear in the paper transport section	<p>A. Check if there is any rattling on ASYS-LVR-E-RLR-BUF. If there is, replace ASYB-SFT-EXT-RLR-DRV-BUF, ASYS-LVR-E-RLR-BUF, GEAR-IDLER-EXT-BUF, GEAR1-EXT-RLR-BUF and GEAR2-EXT-RLR-BUF.</p>

<p>Check that there is no rattling.</p>

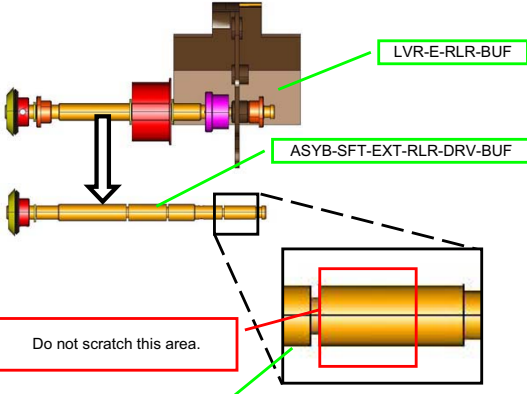
<p>Scratch on the shaft</p>

<p>Do not scratch this area.</p>

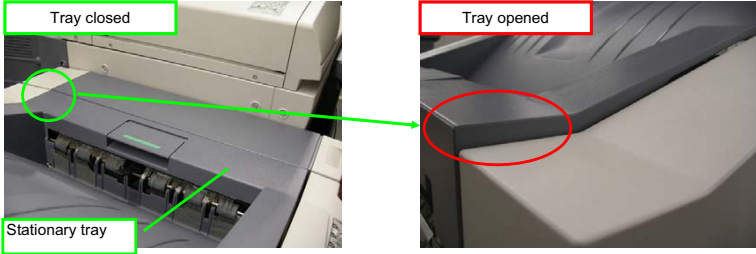
Error code	Phenomenon	Possible cause	Items to confirm / Countermeasures	Precautions / Remarks
EA40	Paper jamming	1. Stationary tray left open (A cover-open error occurs if the stationary tray is left open because the stationary tray opening/closing switch performs false detection during operation.)	Close the stationary tray securely if it is open.

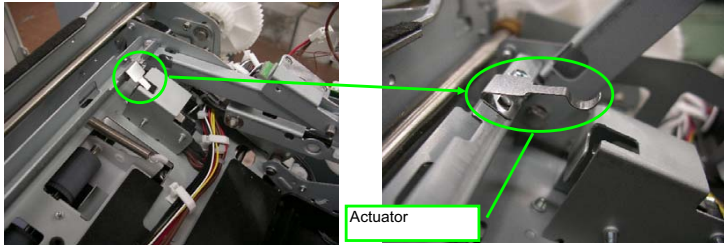
2. Stationary tray opening/closing switch actuator deformed (A cover-open error occurs if the actuator is deformed because the stationary tray opening/closing switch cannot be turned and performs false detection.)	Replace PLT-OPEN-SW-BUF if the actuator is deformed.

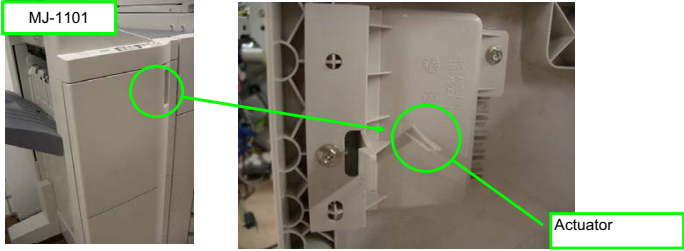
3. Front cover switch actuator deformed (MJ-1101) (A cover-open error occurs if the actuator is deformed because the front cover switch cannot be turned and it performs false detection.)	Replace HNDL-DOOR if the actuator is deformed or damaged.

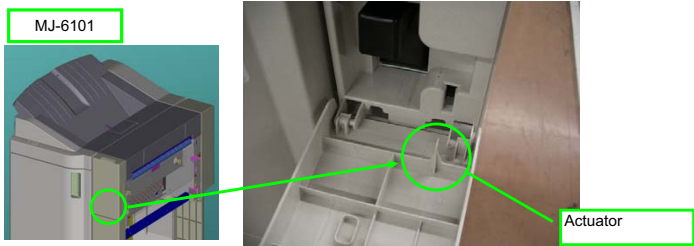
3. Front cover switch actuator deformed (MJ-6101) (A cover-open error occurs if the actuator is deformed because the front cover switch cannot be turned and performs false detection.)	Replace COVER-F-DOOR-P if the actuator is deformed or damaged.

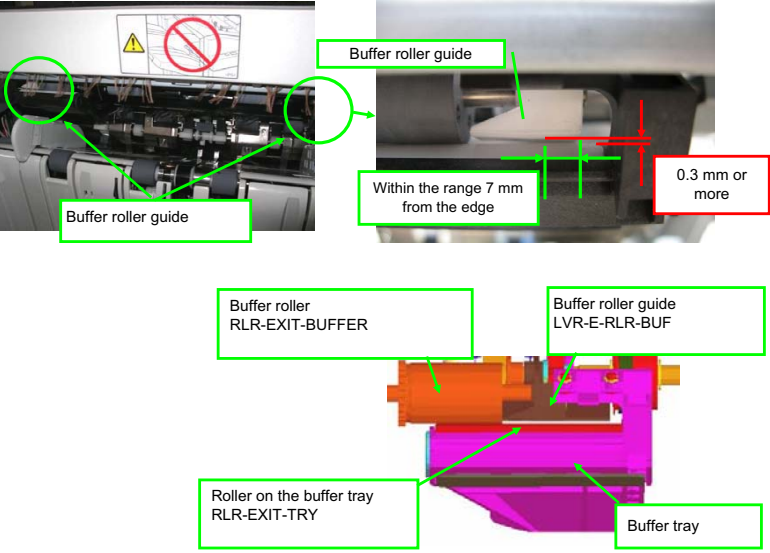
<p>3. Improper roller gap on the buffer roller guide and buffer tray</p>	<p>Turn the power OFF. Then check the gap between rollers on the buffer roller guide and the buffer tray while the buffer roller is left lowered. If the gap does not reach 0.3 mm, replace the buffer roller guides (LVR-E-RLR-BUF) on both front and rear sides.</p>

<p>Check the gap within the range 7 mm from the edge of the buffer roller guide.</p>

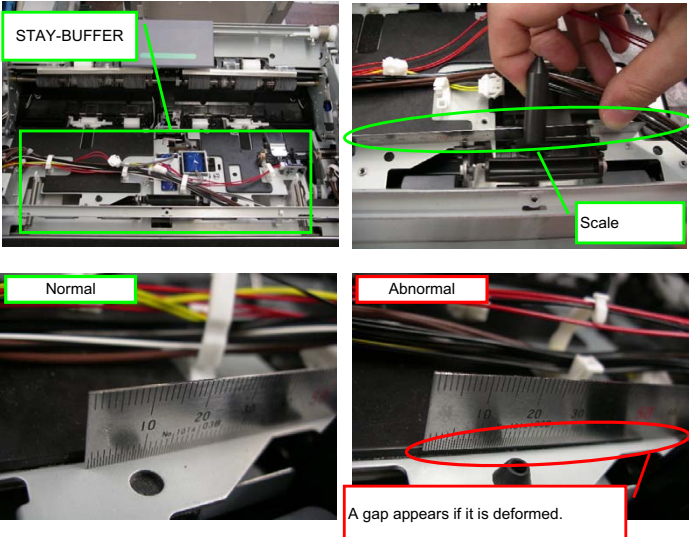
Error code	Phenomenon	Possible cause	Items to confirm / Countermeasures	Precautions / Remarks
EA70 EA60 CC30 CC41	<p>- When more than one sheet of paper is loaded on the buffer tray, the first sheet is pushed out of the tray by the second sheet.</p> <p>- When more than one sheet of paper is loaded on the buffer tray, the leading edge of the second sheet is caught and thus a paper jam occurs.</p> <p>- When paper is transported from the buffer tray to the finishing tray, the paper is run on the front or rear alignment plate.</p> <p>- When paper is loaded on the finishing tray, the front and rear alignment plates excessively push the paper.</p> <p>- When paper is transported from the finishing tray to the movable tray, the paper exit guide catches the paper and thus a motor error occurs because the paper cannot exit.</p>	6. STAY-BUFFER deformed	<p>Remove the bracket of the buffer roller lift solenoid. Then check that STAY-BUFFER is not deformed using a scale or other straight tool. Replace it if it is deformed.</p>

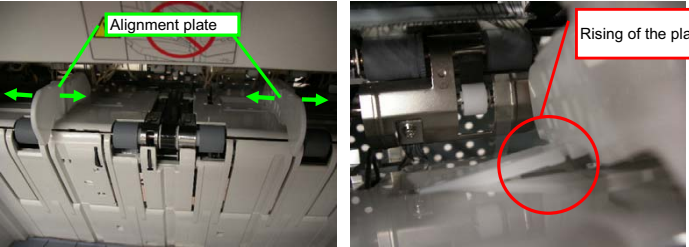
7. Improper installation of alignment plates	<p>If the front or rear alignment plate is removed or its installation is improper, reinstall it. (The alignment plates must not be risen even if they are tilted to the right or left.)</p>

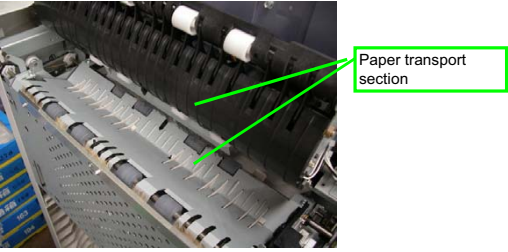
Error code	Phenomenon	Possible cause	Items to confirm / Countermeasures	Precautions / Remarks
EA70 EA60 CC30 CC41	<p>- When more than one sheet of paper is loaded on the buffer tray, the first sheet is pushed out of the tray by the second sheet.</p> <p>- When more than one sheet of paper is loaded on the buffer tray, the leading edge of the second sheet is caught and thus a paper jam occurs.</p>	10. Abnormalities in paper transport section	<p>Check if there is any scratch, foreign matter, paper dust or remained paper that disturb the paper transport in the paper transport section. Remove if any.</p>

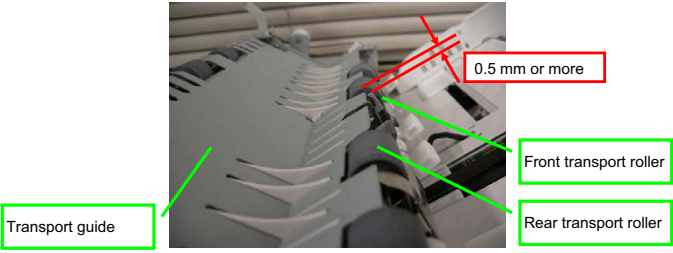
<p>- When paper is transported from the buffer tray to the finishing tray, the paper is run on the front or rear alignment plate.</p> <p>- When paper is loaded on the finishing tray, the front and rear alignment plates excessively push the paper.</p> <p>- When paper is transported from the finishing tray to the movable tray, the paper exit guide catches the paper and thus a motor error occurs because the paper cannot exit.</p>	11. Insufficient ejection of front/rear transport roller	<p>If the front and rear transport rollers are not ejected from the transport guide at 0.5 mm or more, replace the transport guide (GUIDE-FEED-LOW).</p>

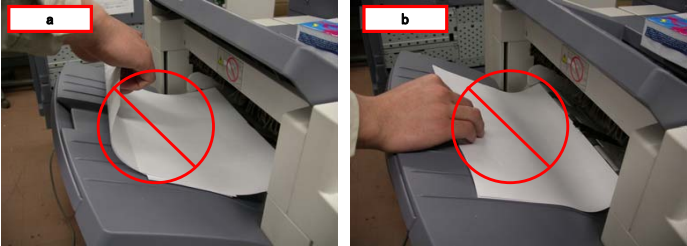
12. Wrong operation by users during printing	<p>An EA70 error may occur if paper exit is disturbed during printing.</p>

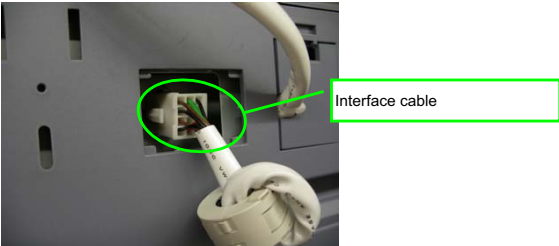
Error code	Phenomenon	Possible cause	Items to confirm / Countermeasures	Precautions / Remarks
EAE0	Paper jamming	1. Loose connection (Loose connection may cause false operation or detection.)	A. Check if the interface cable of the Finisher is connected securely. Reconnect it if not.

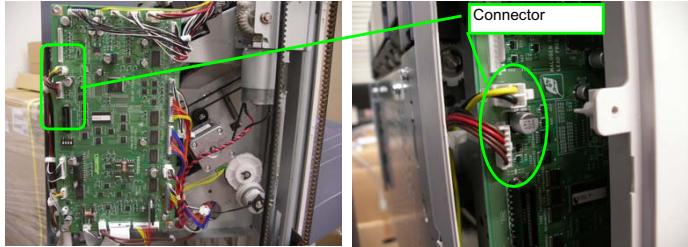
B. Check if the connectors (CN12 and CN14) of the Finisher control PC board are connected securely. Reconnect them if not.

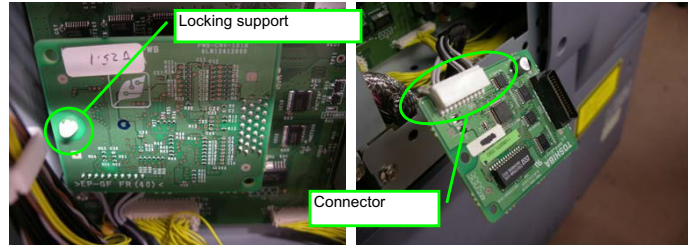
C. Check if the connectors (CN1 and CN2) of the CNV board are connected securely and the locking support is installed properly. Reconnect them if not.

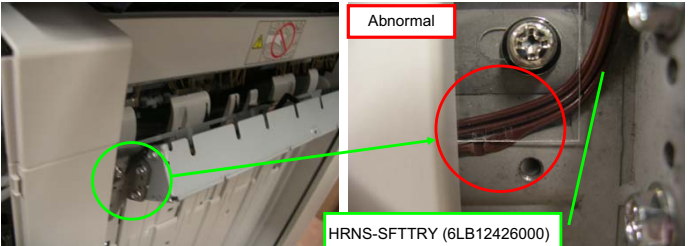
2. Movable tray paper exist sensor harness (HRNS-SFTTRY) short circuited (Loose connection may cause false operation or detection.)	Check if the harness (HRMS-SFTTRY) of the movable tray paper exist sensor is short circuited or if its wiring is proper. Replace the harness if it is short circuited.

The harness wiring must be under the screw and inside of the Mylar, and the harness must be wired along with the groove of the plate as shown on the left. Be sure that the harness is covered by the Mylar.

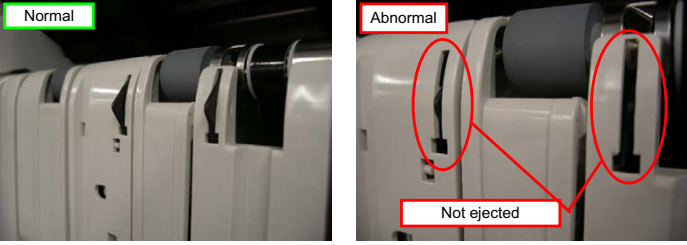
<p>2. False detection caused by the removed actuator spring of the movable tray paper-full sensor (The actuator not ejected)</p>	<p>Reinstall SPG-ACTR-01-TRAY if it is removed.</p>

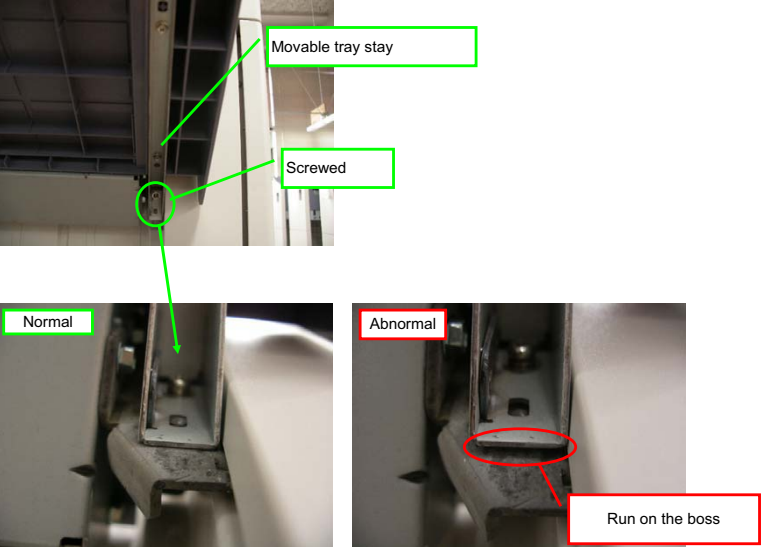
<p>The image shows two side-by-side views of the actuator. The left view is labeled 'Normal' and shows the actuator fully extended. The right view is labeled 'Abnormal' and shows the actuator partially retracted, with a red circle and the text 'Not ejected' pointing to it.</p>	
		<p>3. Improper installation of the movable tray</p> <p>(An error occurs if the actuator of the movable tray paper-full sensor cannot be pushed due to the improper installation of the movable tray.)</p>	<p>The movable tray may not be installed properly (the stay of the movable tray may run on the boss). Reinstall the movable tray.</p>

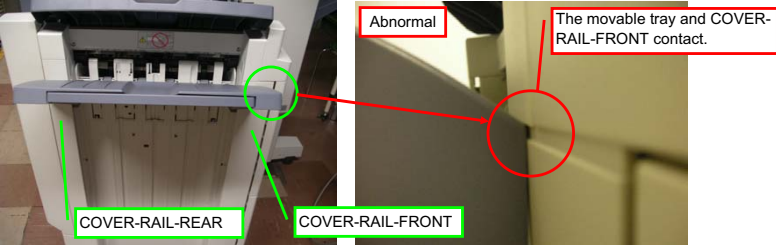
Error code	Phenomenon	Possible cause	Items to confirm / Countermeasures	Precautions / Remarks
CB31	An error occurs because the movable tray cannot be lowered (or lifted up) to the specified position after printing operation.	1. The movable tray cannot be lowered or lifted up because the load is applied to the movable tray by the contact of the tray and COVER-RAIL-FRONT (or COVER-RAIL-REAR).	<p>Check if the inner hooks of COVER-RAIL-FRONT and COVER-RAIL-REAR are properly latched. Reinstall them if not.</p>

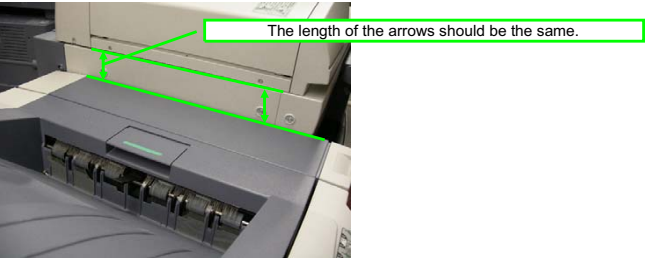
<p>2. Improper installation height</p> <p>(Paper is not properly transported from the equipment to the Finisher if each height is improper.)</p>	<p>A. Confirm that the Finisher is installed horizontally (the height of its front side and that of its rear side are the same).</p>

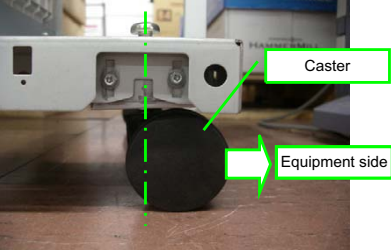
<p>B. To keep the installation height of the Finisher stable, it is preferable that the casters are faced to the equipment side.</p>

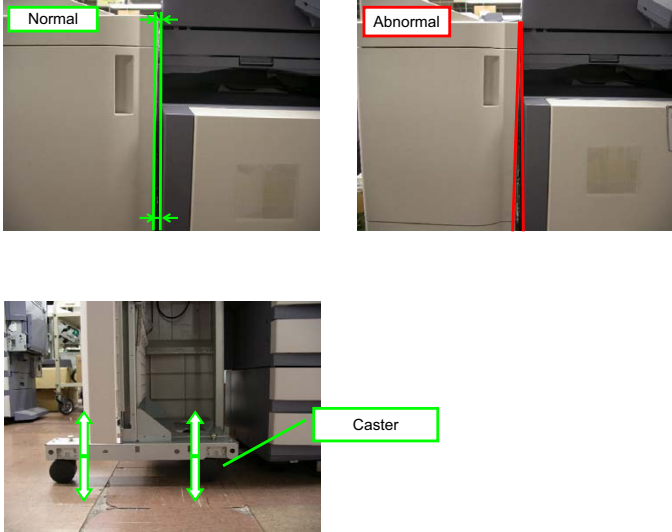
Error code	Phenomenon	Possible cause	Items to confirm / Countermeasures	Precautions / Remarks
CC41 EA20 EA40 EA70	<ul style="list-style-type: none"> - Paper jams at the entrance section of the Finisher (or the Hole Punch Unit) - Folded paper edge - Improper closing of the stationary tray 	3. Tilted Finisher (Paper is not properly transported from the equipment to the Finisher if the Finisher is tilted.)	If the Finisher is tilted as shown below, adjust the height of each caster to make the Finisher horizontal to the equipment.

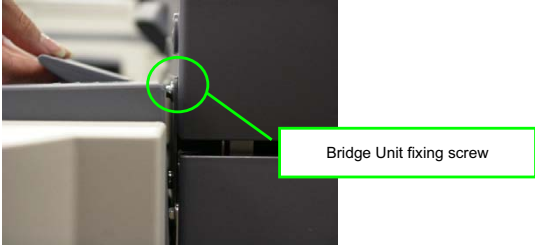
If the Finisher is tilted, the fixing screw of the Bridge Unit and the stationary tray may be contacted when the stationary tray is opened or closed.

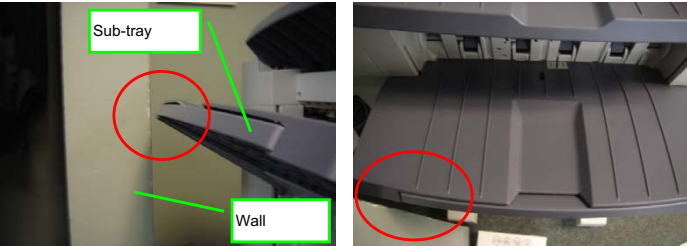
4. Improper exit of large paper	Secure enough space for drawing out the sub-tray when installing the Finisher. If the Finisher is installed as shown in the picture below, the trailing edge of large paper may be jammed when it is exiting.

Be sure to draw out the sub-tray when large paper is used. Otherwise false stacking, paper dropping or an EA70 error may occur.

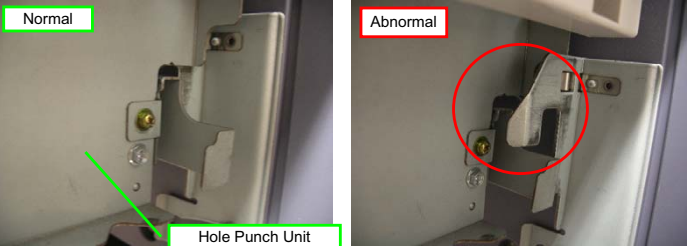
5. Improper connection between the equipment and the Hole Punch Unit (Paper is not properly transported from the equipment to the Hole Punch Unit if they are not connected correctly.)	When the Hole Punch Unit is installed, check if the connection point is shifted forward or backward.
