**ADDITIONAL  
MAINTENANCE INSTRUCTIONS**

**NAVY TYPE ACB-1600HR  
CIRCUIT BREAKER**

**WESTINGHOUSE TYPE DBN-1016**

**TECHNICAL MANUAL 32-855-11C1**

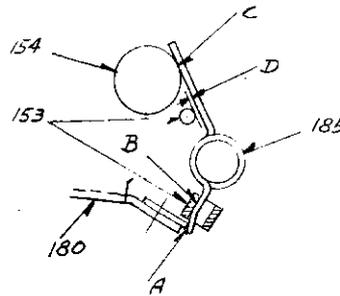
RESETTING

CHECK TO SEE IF TRIGGER (180) WILL RESET FROM THIS POSITION AND IF NECESSARY CLEAN AND REMOVE BURRS FROM SURFACE "E" ON LATCH (153)
