*MJ-1101 Service Manual Addendum*  
Supplement to the Troubleshooting Section

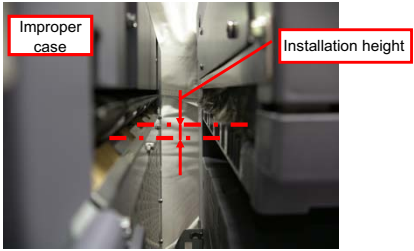
<p>C. When installing the Finisher in the equipment, make sure that the height of the Finisher is proper. If it is not, the Bridge Unit exit Mylar may be deformed, and thus the deformed Mylar may obstruct the paper transport path.</p>

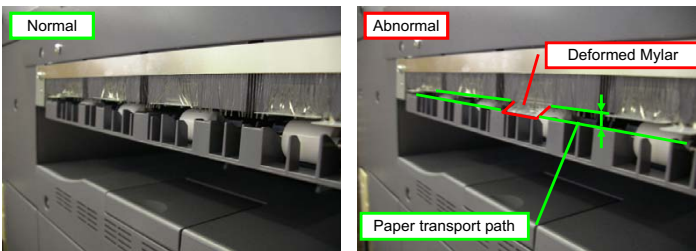
<p>2. Bridge Unit exit Mylar deformed Correct it if deformed.</p>	<p>Check if the Mylar attached to the exit of the Bridge Unit is deformed and obstructing the paper transport path.</p>

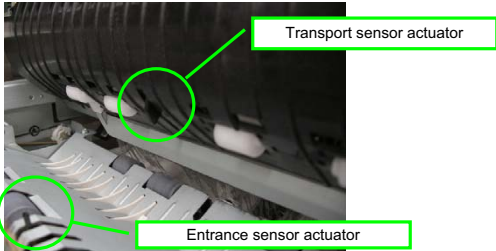
Error code	Phenomenon	Possible cause	Items to confirm / Countermeasures	Precautions / Remarks
EA20	<p>- Paper jams at the entrance section of the Finisher (or the Hole Punch Unit)</p> <p>- Folded paper edge</p> <p>- Paper jams C2in the buffer tray section</p> <p>- C2Paper exit problems on the finishing tray</p>	<p>5. False operation of the entrance sensor or the transport sensor</p> <p>(An error may occur when the entrance sensor or the transport sensor does not perform proper detection.)</p>	<p>B. Check if the actuators of the entrance sensor and the transport sensor are operating smoothly. If they are not, remove the actuator and check if there is any paper dust or foreign matter between the shaft and the hole. Clean if there is.</p>

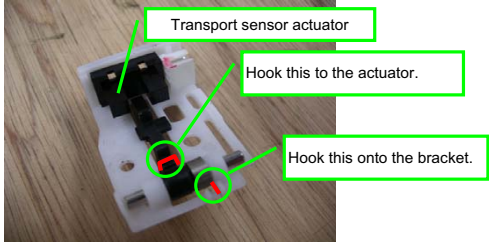
<p>Operation check of the transport sensor actuator: Rotate the shaft slowly. If the actuator is not rotated together, its operation is normal.</p>

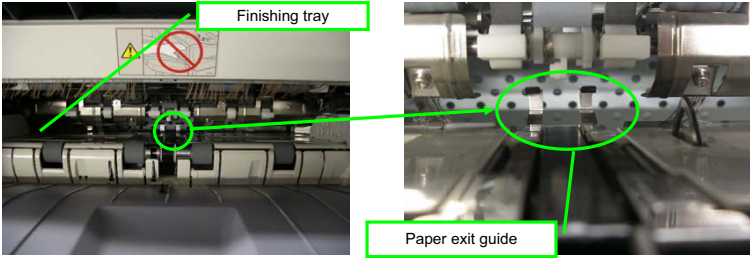
<p>6. False operation of the paper exit guide</p> <p>(An error may occur when the paper exit guide is not operating properly because paper may remain on the finishing tray or not exit properly during sort or stapling exit.)</p>	<p>Replace SPG-SFFD-SUPT-SF (6LB090140) if the paper exit guide is not operating properly.</p>

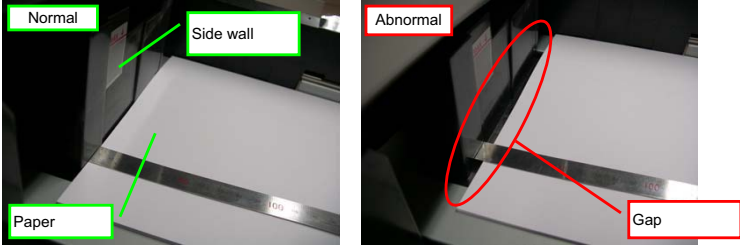
<p>7. Paper not placed properly in the drawer</p> <p>(Paper may be skewed if there is extra gap between the paper and the side wall in the drawer and thus may cause a jam on the Finisher transport path.)</p>

<p>Be sure to lock the side wall.</p>

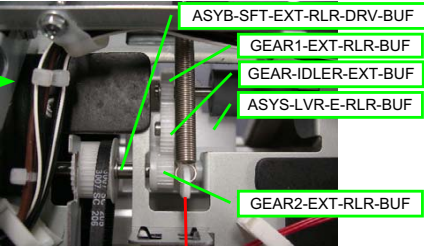
Error code	Phenomenon	Possible cause	Items to confirm / Countermeasures	Precautions / Remarks
EA20	<ul style="list-style-type: none"> <li>- Paper jams at the entrance section of the Finisher (or the Hole Punch Unit)</li> <li>- Folded paper edge</li> <li>- Paper jams C2in the buffer tray section</li> <li>- C2Paper exit problems on the finishing tray</li> </ul>	8. Drive not transmitted from the gear in the paper transport section	<p>A. Check if there is any rattling on ASYS-LVR-E-RLR-BUF. If there is, replace ASYB-SFT-EXT-RLR-DRV-BUF, ASYS-LVR-E-RLR-BUF, GEAR-IDLER-EXT-BUF, GEAR1-EXT-RLR-BUF and GEAR2-EXT-RLR-BUF.</p>

<p>Check that there is no rattling.</p>

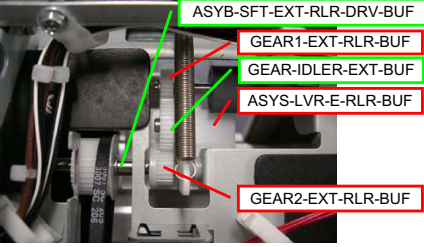
<p>B. Check if the gear teeth of GEAR-IDLER-EXT-BUF, GEAR1-EXT-RLR-BUF and GEAR2-EXT-RLR-BUF mesh correctly. If any of them does not mesh correctly, replace ASYB-SFT-EXT-RLR-DRV-BUF, ASYS-LVR-E-RLR-BUF, GEAR-IDLER-EXT-BUF, GEAR1-EXT-RLR-BUF or GEAR2-EXT-RLR-BUF.</p>

<p>When replacing, be sure not to scratch the shaft (ASYB-SFT-EXT-RLR-DRV-BUF).</p>

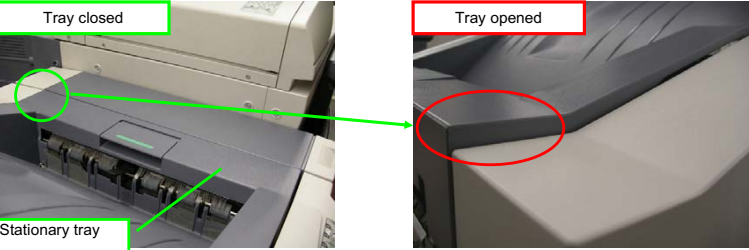
Error code	Phenomenon	Possible cause	Items to confirm / Countermeasures	Precautions / Remarks
EA40	Paper jamming	<p>1. Stationary tray left open</p> <p>(A cover-open error occurs if the stationary tray is left open because the stationary tray opening/closing switch performs false detection during operation.)</p>	<p>Close the stationary tray securely if it is open.</p>

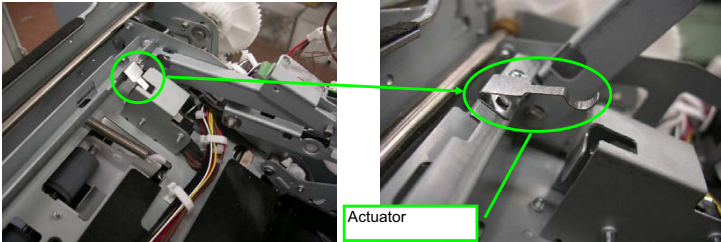
<p>2. Stationary tray opening/closing switch actuator deformed</p> <p>(A cover-open error occurs if the actuator is deformed because the stationary tray opening/closing switch cannot be turned and performs false detection.)</p>	<p>Replace PLT-OPEN-SW-BUF if the actuator is deformed.</p>

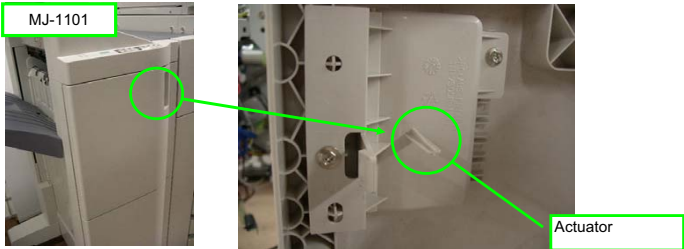
<p>3. Front cover switch actuator deformed (MJ-1101)</p> <p>(A cover-open error occurs if the actuator is deformed because the front cover switch cannot be turned and it performs false detection.)</p>	<p>Replace HNDL-DOOR if the actuator is deformed or damaged.</p>

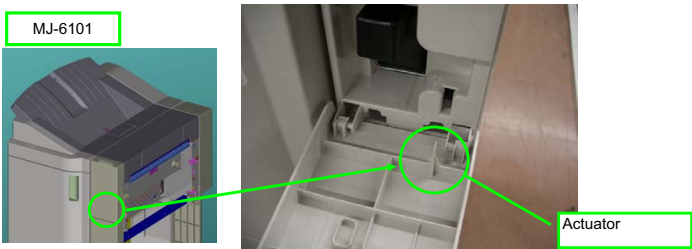
<p>3. Front cover switch actuator deformed (MJ-6101)</p> <p>(A cover-open error occurs if the actuator is deformed because the front cover switch cannot be turned and performs false detection.)</p>	<p>Replace COVER-F-DOOR-P if the actuator is deformed or damaged.</p>

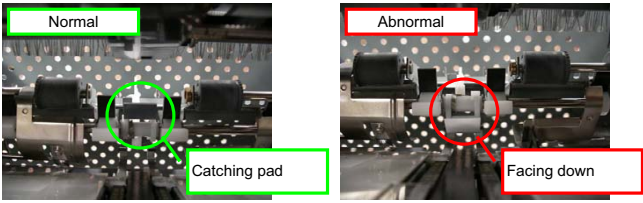
Error code	Phenomenon	Possible cause	Items to confirm / Countermeasures	Precautions / Remarks
EA70 EA60 CC30 CC41	<p>- When more than one sheet of paper is loaded on the buffer tray, the first sheet is pushed out of the tray by the second sheet.</p> <p>- When more than one sheet of paper is loaded on the buffer tray, the leading edge of the second sheet is caught and thus a paper jam occurs.</p> <p>- When paper is transported from the buffer tray to the finishing tray, the paper is run on the front or rear alignment plate.</p> <p>- When paper is loaded on the finishing tray, the front and rear alignment plates excessively push the paper.</p> <p>- When paper is transported from the finishing tray to the movable tray, the paper exit guide catches the paper and thus a motor error occurs because the paper cannot exit.</p>	<p>1. Catching pad deformed or damaged</p> <p>(Paper is not aligned properly due to the deformed or damaged catching pad.)</p>	<p>Check if the catching pad in the Finisher paper exit section is properly attached. Replace it if it is deformed or damaged.</p>

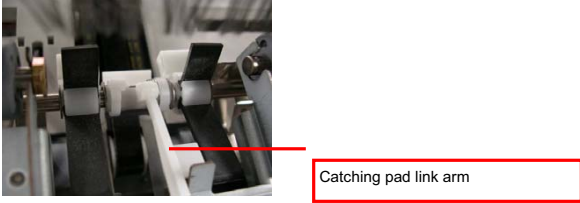
<p>2. Catching pad link arm deformed, damaged or removed</p> <p>(Paper is not aligned properly because the link arm of the catching pad is deformed, damaged or removed.)</p>	<p>Check if the catching pad in the Finisher paper exit section is properly attached. If its link arm is deformed, damaged or removed, replace ARM-SOL-ALIGN (6LB100080).</p>

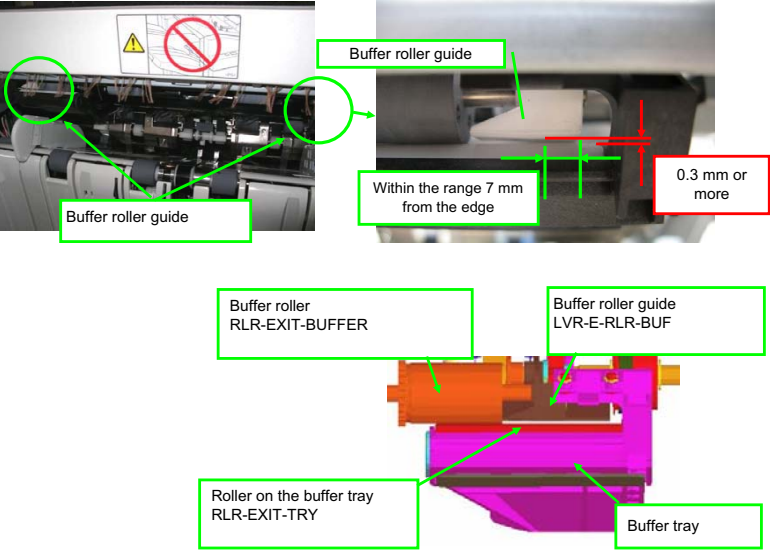
<p>3. Improper roller gap on the buffer roller guide and buffer tray</p>	<p>Turn the power OFF. Then check the gap between rollers on the buffer roller guide and the buffer tray while the buffer roller is left lowered. If the gap does not reach 0.3 mm, replace the buffer roller guides (LVR-E-RLR-BUF) on both front and rear sides.</p>

<p>Check the gap within the range 7 mm from the edge of the buffer roller guide.</p>

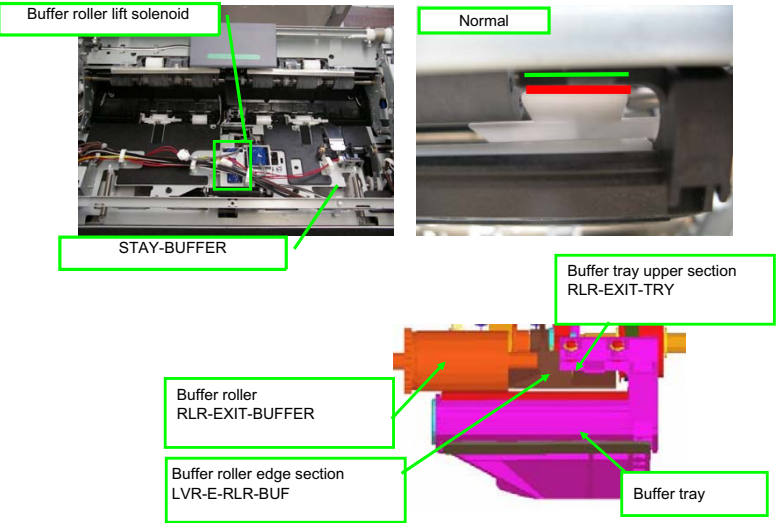
Error code	Phenomenon	Possible cause	Items to confirm / Countermeasures	Precautions / Remarks
EA70 EA60 CC30 CC41	<p>- When more than one sheet of paper is loaded on the buffer tray, the first sheet is pushed out of the tray by the second sheet.</p> <p>- When more than one sheet of paper is loaded on the buffer tray, the leading edge of the second sheet is caught and thus a paper jam occurs.</p> <p>- When paper is transported from the buffer tray to the finishing tray, the paper is run on the front or rear alignment plate.</p> <p>- When paper is loaded on the finishing tray, the front and rear alignment plates excessively push the paper.</p> <p>- When paper is transported from the finishing tray to the movable tray, the paper exit guide catches the paper and thus a motor error occurs because the paper cannot exit.</p>	<p>4. Improper spacing on the edge section of the buffer roller guide and the buffer tray upper section</p>	<p>Turn the power OFF and pull the plunger of the buffer roller lift solenoid by hand. Then check the spacing on the edge section of the buffer roller guide and the buffer tray upper section while the buffer roller is lifted up. If the edge section of the buffer roller guide is not lower than the buffer tray upper section, replace STAY-BUFFER.</p>

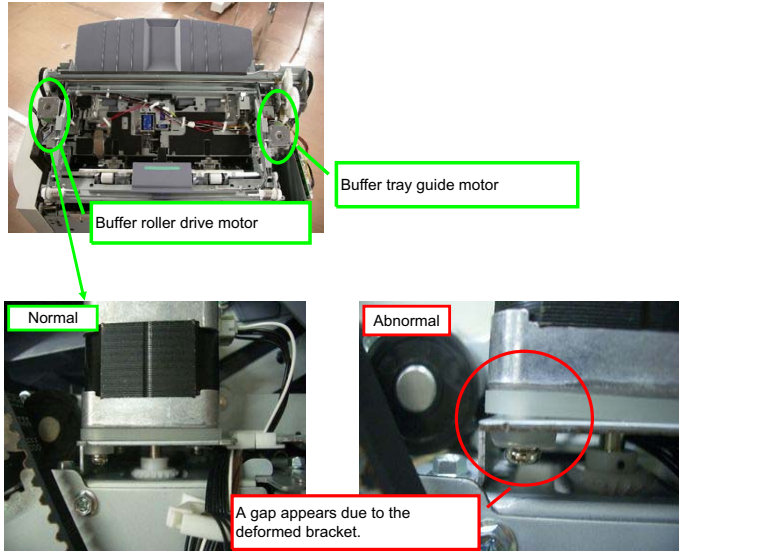
<p>5. Motor bracket deformed</p> <p>(The bracket of the buffer tray guide motor or the buffer roller drive motor is deformed and thus drive is not transmitted.)</p>	<p>If the buffer tray guide motor bracket (HLDR-TRAY-BUF) or the buffer roller drive motor bracket (HLDR-MOTR-BUFFER) is deformed, replace it.</p>

<p>- If the joint surfaces of the stationary tray and the rear lower cover (or the control panel unit) are shifted 4 mm or more, the motor bracket may be deformed.</p> <p>- Do not hold the stationary tray when unpacking.</p>

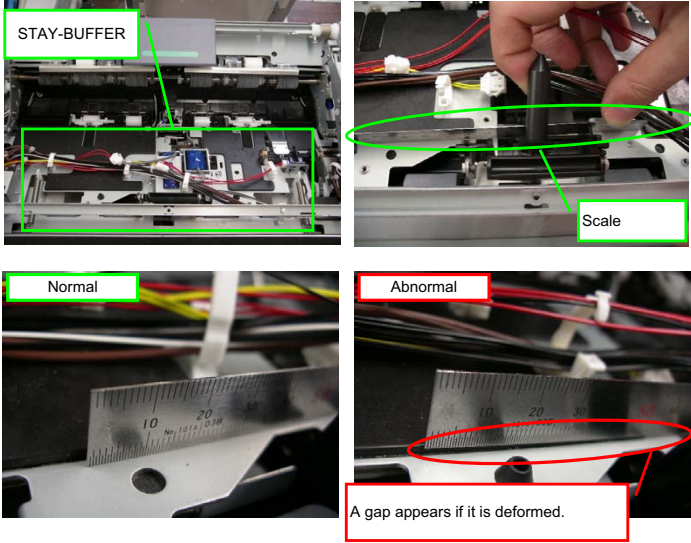
Error code	Phenomenon	Possible cause	Items to confirm / Countermeasures	Precautions / Remarks
EA70 EA60 CC30 CC41	<p>- When more than one sheet of paper is loaded on the buffer tray, the first sheet is pushed out of the tray by the second sheet.</p> <p>- When more than one sheet of paper is loaded on the buffer tray, the leading edge of the second sheet is caught and thus a paper jam occurs.</p> <p>- When paper is transported from the buffer tray to the finishing tray, the paper is run on the front or rear alignment plate.</p> <p>- When paper is loaded on the finishing tray, the front and rear alignment plates excessively push the paper.</p> <p>- When paper is transported from the finishing tray to the movable tray, the paper exit guide catches the paper and thus a motor error occurs because the paper cannot exit.</p>	6. STAY-BUFFER deformed	<p>Remove the bracket of the buffer roller lift solenoid. Then check that STAY-BUFFER is not deformed using a scale or other straight tool. Replace it if it is deformed.</p>

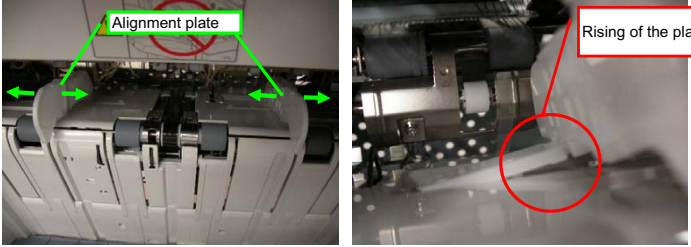
7. Improper installation of alignment plates	<p>If the front or rear alignment plate is removed or its installation is improper, reinstall it. (The alignment plates must not be risen even if they are tilted to the right or left.)</p>

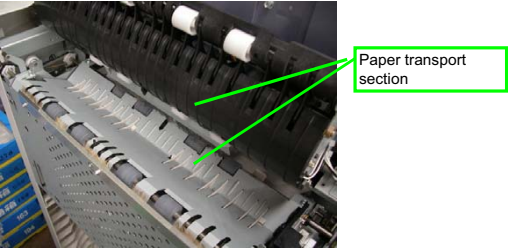
Error code	Phenomenon	Possible cause	Items to confirm / Countermeasures	Precautions / Remarks
EA70 EA60 CC30 CC41	<p>- When more than one sheet of paper is loaded on the buffer tray, the first sheet is pushed out of the tray by the second sheet.</p> <p>- When more than one sheet of paper is loaded on the buffer tray, the leading edge of the second sheet is caught and thus a paper jam occurs.</p> <p>- When paper is transported from the buffer tray to the finishing tray, the paper is run on the front or rear alignment plate.</p> <p>- When paper is loaded on the finishing tray, the front and rear alignment plates excessively push the paper.</p> <p>- When paper is transported from the finishing tray to the movable tray, the paper exit guide catches the paper and thus a motor error occurs because the paper cannot exit.</p>	<p>10. Abnormalities in paper transport section</p>	<p>Check if there is any scratch, foreign matter, paper dust or remained paper that disturb the paper transport in the paper transport section. Remove if any.</p>

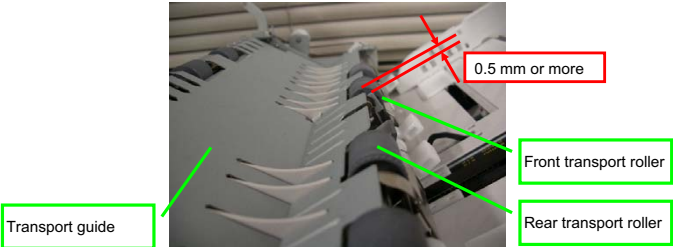
<p>11. Insufficient ejection of front/rear transport roller</p>	<p>If the front and rear transport rollers are not ejected from the transport guide at 0.5 mm or more, replace the transport guide (GUIDE-FEED-LOW).</p>

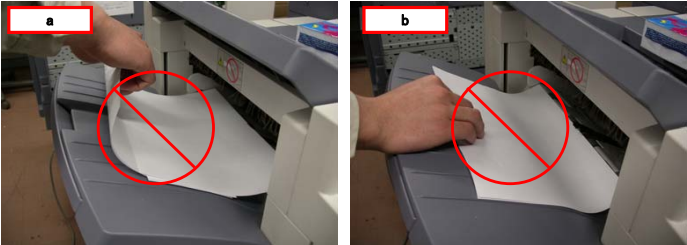
<p>12. Wrong operation by users during printing</p>	<p>An EA70 error may occur if paper exit is disturbed during printing.</p>

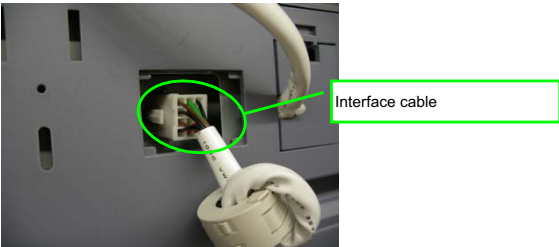
Error code	Phenomenon	Possible cause	Items to confirm / Countermeasures	Precautions / Remarks
EAE0	Paper jamming	1. Loose connection (Loose connection may cause false operation or detection.)	A. Check if the interface cable of the Finisher is connected securely. Reconnect it if not.

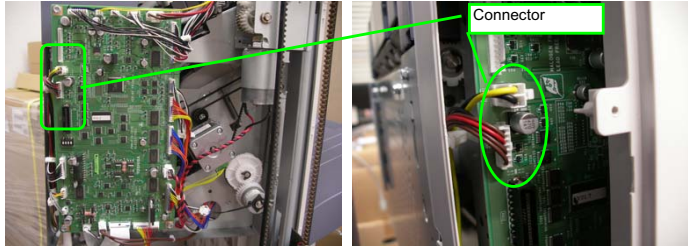
B. Check if the connectors (CN12 and CN14) of the Finisher control PC board are connected securely. Reconnect them if not.

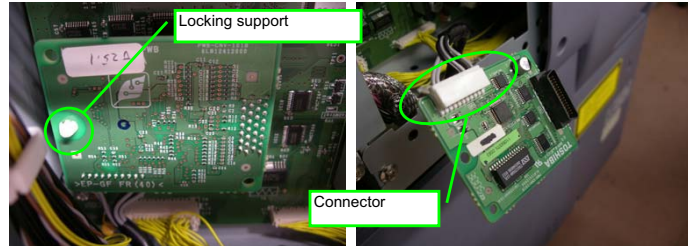
C. Check if the connectors (CN1 and CN2) of the CNV board are connected securely and the locking support is installed properly. Reconnect them if not.

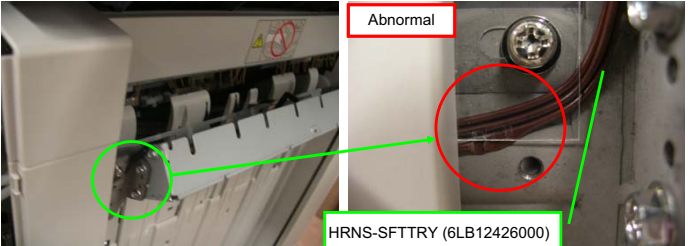
2. Movable tray paper exist sensor harness (HRNS-SFTTRY) short circuited (Loose connection may cause false operation or detection.)	Check if the harness (HRMS-SFTTRY) of the movable tray paper exist sensor is short circuited or if its wiring is proper. Replace the harness if it is short circuited.

The harness wiring must be under the screw and inside of the Mylar, and the harness must be wired along with the groove of the plate as shown on the left. Be sure that the harness is covered by the Mylar.

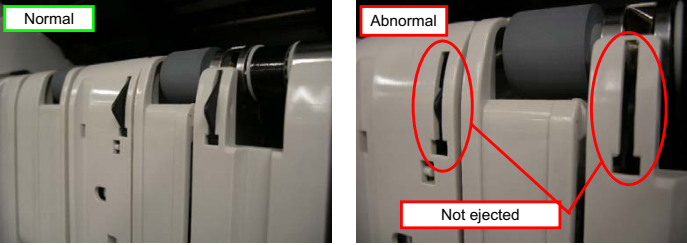
Error code	Phenomenon	Possible cause	Items to confirm / Countermeasures	Precautions / Remarks
CB31	<p>- The movable tray is lifted up after the power is turned ON. An error occurs when it stops at the upper limit position. (Initialization does not finish.)</p> <p>- The movable tray is lowered after the power is turned ON. An error occurs before it is lowered to the specified position. (Initialization finishes.)</p>	<p>1. False detection of the movable tray paper-full sensor due to its deformed/damaged actuator (The actuator not ejected)</p>	<p>If the actuator cannot be ejected due to its deformation or damage, replace ACTR-01-SNSR-VER01-TRAY.</p>

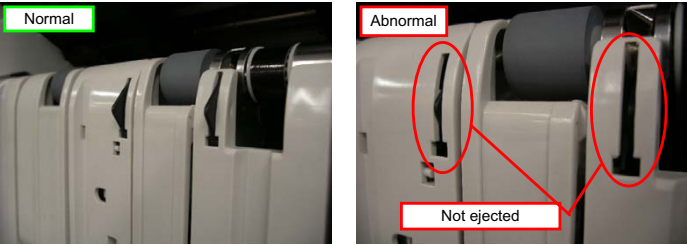
<p>2. False detection caused by the removed actuator spring of the movable tray paper-full sensor (The actuator not ejected)</p>	<p>Reinstall SPG-ACTR-01-TRAY if it is removed.</p>

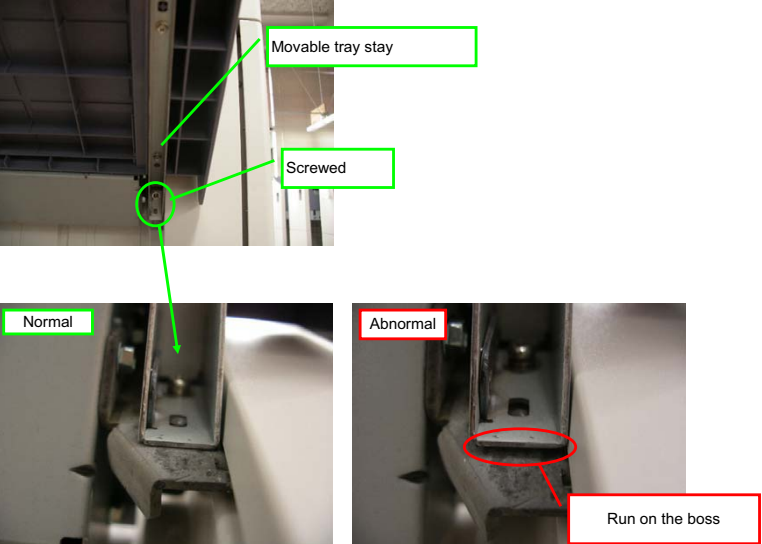
<p>The image shows two side-by-side views of the actuator. The left view is labeled 'Normal' and shows the actuator fully extended. The right view is labeled 'Abnormal' and shows the actuator retracted, with a red circle and the text 'Not ejected' pointing to it.</p>	
		<p>3. Improper installation of the movable tray</p> <p>(An error occurs if the actuator of the movable tray paper-full sensor cannot be pushed due to the improper installation of the movable tray.)</p>	<p>The movable tray may not be installed properly (the stay of the movable tray may run on the boss). Reinstall the movable tray.</p>

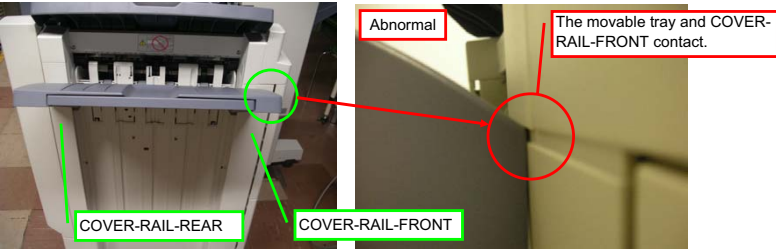
Error code	Phenomenon	Possible cause	Items to confirm / Countermeasures	Precautions / Remarks
CB31	An error occurs because the movable tray cannot be lowered (or lifted up) to the specified position after printing operation.	1. The movable tray cannot be lowered or lifted up because the load is applied to the movable tray by the contact of the tray and COVER-RAIL-FRONT (or COVER-RAIL-REAR).	<p data-bbox="602 206 1381 245">Check if the inner hooks of COVER-RAIL-FRONT and COVER-RAIL-REAR are properly latched. Reinstall them if not.</p>

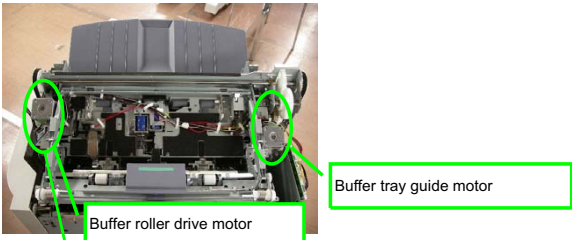
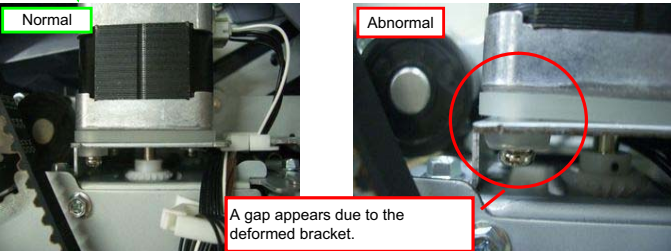
Error code	Phenomenon	Possible cause	Items to confirm / Countermeasures	Precautions / Remarks
CC41 EA20 EA40 EA70	<p>- Paper jams at the entrance section of the Finisher (or the Hole Punch Unit)</p> <p>- Folded paper edge</p> <p>- Improper closing of the stationary tray</p>	<p>1. Motor bracket deformed</p> <p>(The bracket of the buffer tray guide motor or the buffer roller drive motor is deformed and thus drive is not transmitted.)</p>	<p>If the buffer tray guide motor bracket (HLDR-TRAY-BUF) or the buffer roller drive motor bracket (HLDR-MOTR-BUFFER) is deformed, replace it.</p>

<p>- If the joint surfaces of the stationary tray and the rear lower cover (or the control panel unit) are shifted 4 mm or more, the motor bracket may be deformed.</p> <p>- Do not hold the stationary tray when unpacking.</p>

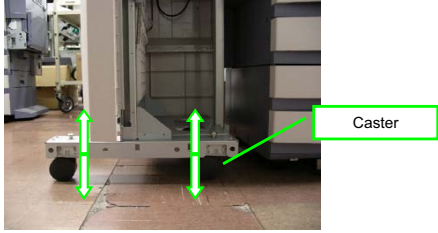
Error code	Phenomenon	Possible cause	Items to confirm / Countermeasures	Precautions / Remarks
CC41 EA20 EA40 EA70	<ul style="list-style-type: none"> <li>- Paper jams at the entrance section of the Finisher (or the Hole Punch Unit)</li> <li>- Folded paper edge</li> <li>- Improper closing of the stationary tray</li> </ul>	3. Tilted Finisher  (Paper is not properly transported from the equipment to the Finisher if the Finisher is tilted.)	<p>If the Finisher is tilted as shown below, adjust the height of each caster to make the Finisher horizontal to the equipment.</p> <div style="display: flex; justify-content: space-around;"> <div style="text-align: center;">
