SERVICE TECHNICAL INFORMATION

ONE POINT REPAIR

MODEL : TV-1402KE/2002KE/2102KE

SUBJECT : Part Number of EEP ROM (IC002/NVM3060)

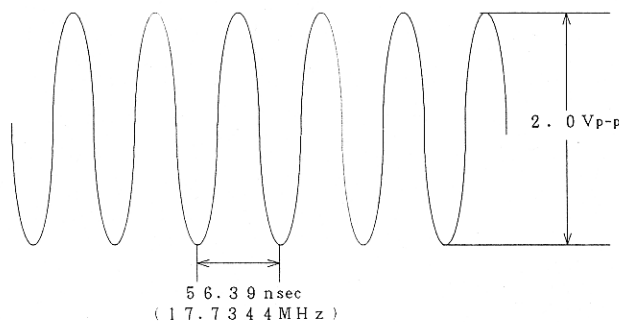
X701 Waveform

There have also been many cases of faulty X701s and faulty soldering. When repairing DIGITAL C.B, always confirm that X701 operates correctly. (See below.)

Note: Voltage of the observed waveform changes in accordance with input impedance and the input amount from probes and oscilloscopes used for measurements.

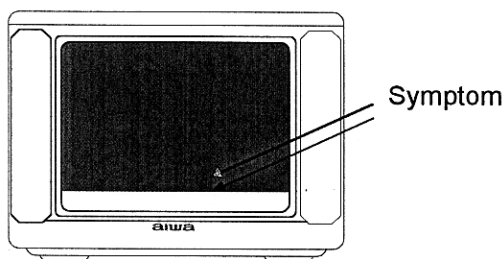
- MODEL : TV-A205 KER/TV-A145 KER
 SUBJECT : Horizontal line appears at bottom of screen
 SYMPTOM : The bottom portion of screen has vertical size compression, and a horizontal line appears at bottom of the screen due to degraded vertical linearity characteristics. (The symptom becomes recognizable after long-duration operation or under no-input status.)

- ACTIONS : Replace the three resistors shown below.

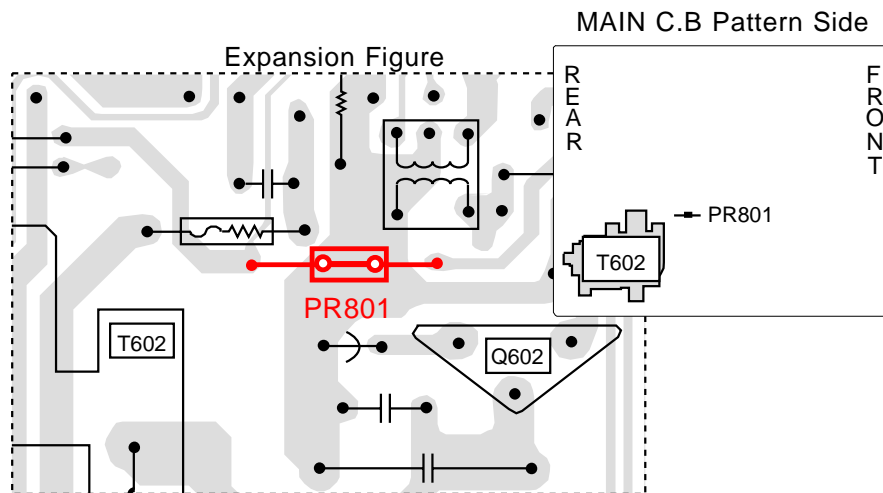
No power due to open IC PROTECTOR (ICP,PR 801) caused by a rush current.

Replace the IC Protector (PR801 1.5A)with one that has higher current capacity(4A).

Ref.	Parts Code	Description	Remarks
PR801	87-A90-094-080	PROTECTOR,4A 491SERIES 60V	-

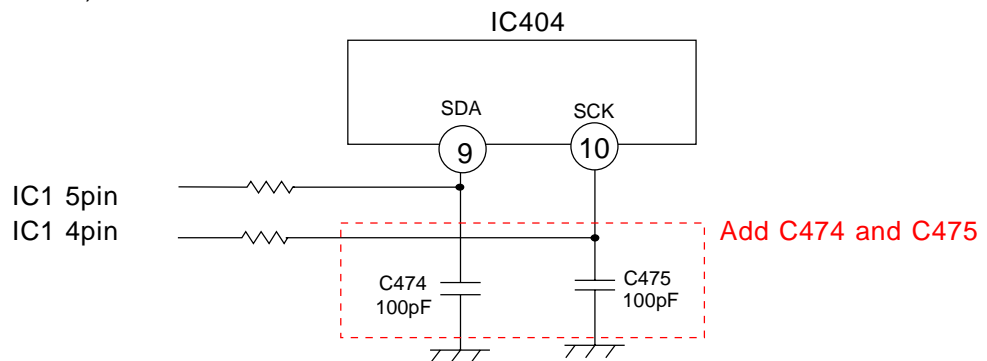
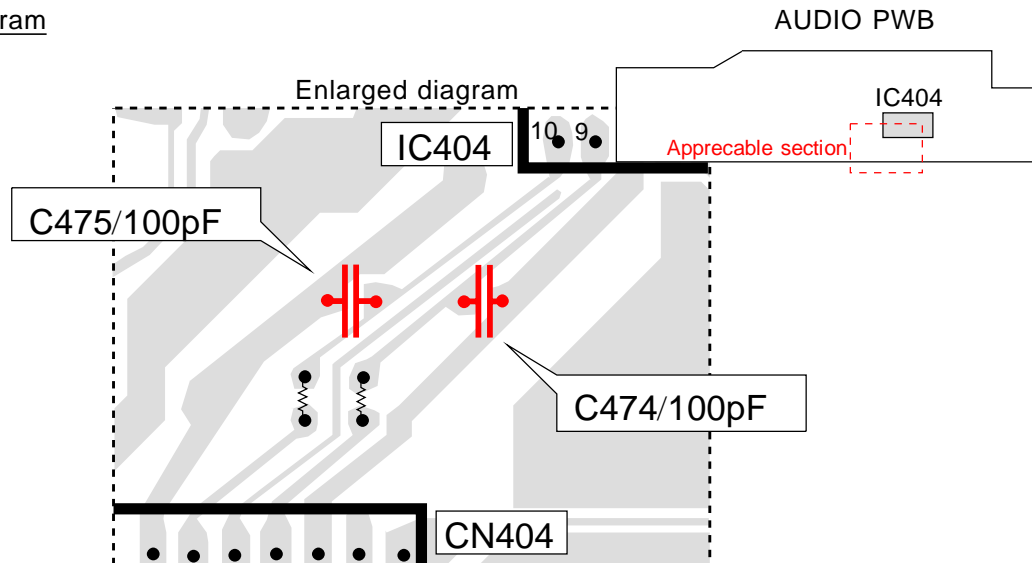
Noise enters into the data line(SDA/SCK) of IC404(volume controller) and causes the following symptoms.

Add a capacitor to the data line(SDA/SCK) of IC404(volume controller) and compose a noise filter(Lands are available).

Ref.	Parts Code	Description	Remarks
C475,C474	87-010-322-080	C-CAP,S 100P-50 J CH GR	-

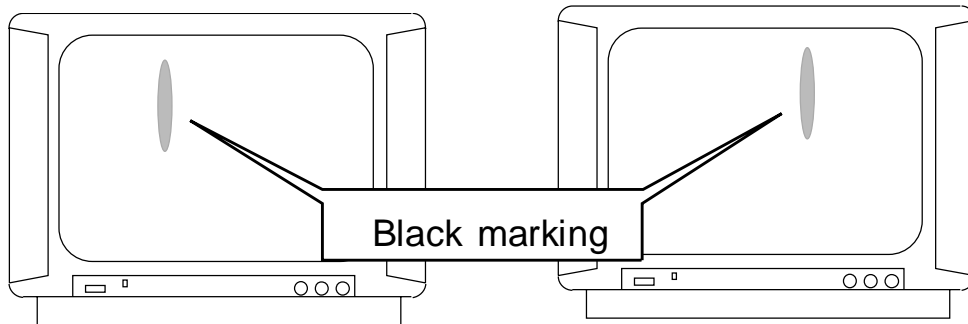
Black marking appear as shown below.
Appearing point defers according to the set.

1. Replace C317(330μF/16V) to 1000μF/16V(87-A10-730-080) regardless the symptom.
2. If already CRT burned in, replace to new CRT.

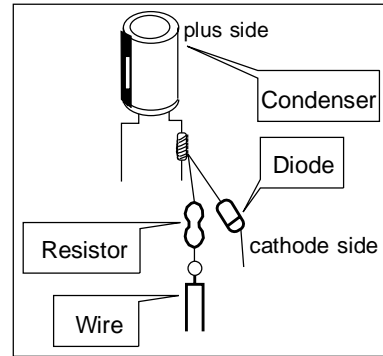
Fig1

No power on due to horizontal output transistor Q601 failure.
Take the following countermeasure in this case.

Prevent the damage of Q601 by adding the curcuit.

1. Replace Q601 after confirming PR801 is open.
2. Connect condenser, diode, resistor, and wire according to the drawing 1.

Be care to the direction of diode and condensor.

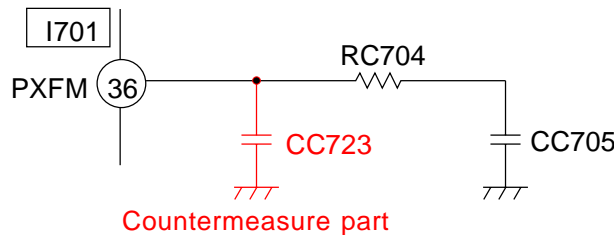
It may happen that " OSD does not display, standby LED does not light " as the flux causes to change the capacity of CC709,CC723.

By replacing the condenser CC709,CC723 from chip type to AXIAL type, the effect of flux reduces.(Please refer the next page for actual installation)

Ref.	Parts Code	Description	Remarks
CC709,CC723	87-A11-073-080	CAP,TC U 22P-50J CH

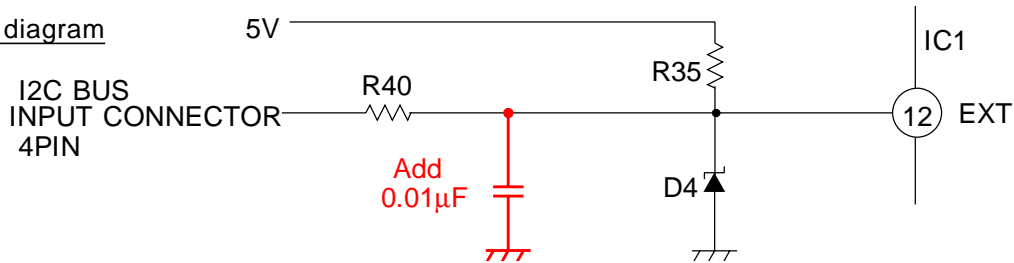
Micro processor may occur malfunction due to the noise of EXT terminal.
To prevent malfunction, attach the condenser 0.01 μ F parallel to D4 on the reverse side.

*Be sure with glue after attaching the condenser.

Ref.	Parts Code	Description	Remarks
-	87-A11-132-080	CAP,TC U 0.01-50 K B	-

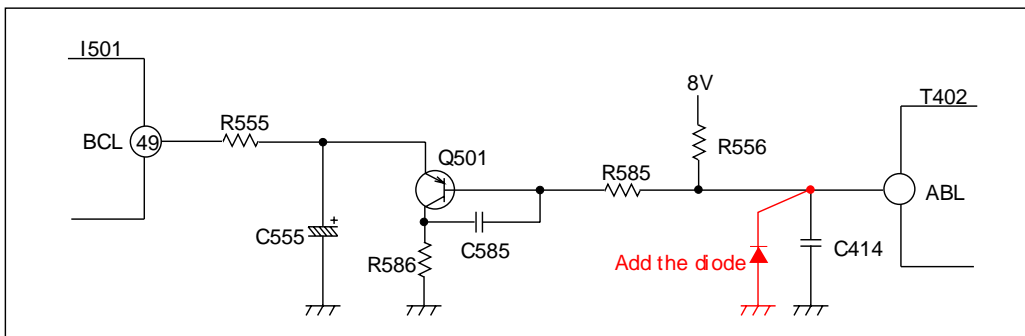
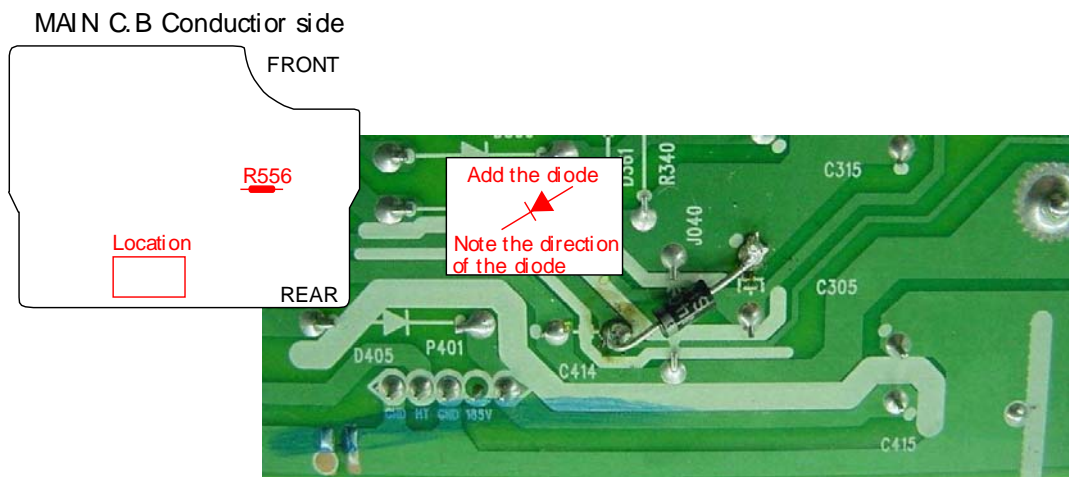
- 1) Replaced a CRT.
- 2) A failure of R556 was confirmed.

1. Add the diode between C414 and C305(GND) as the picture below.
2. Fix it with a glue.
3. Confirm a value of resistor, a color of R556, and replace it if found any defect.

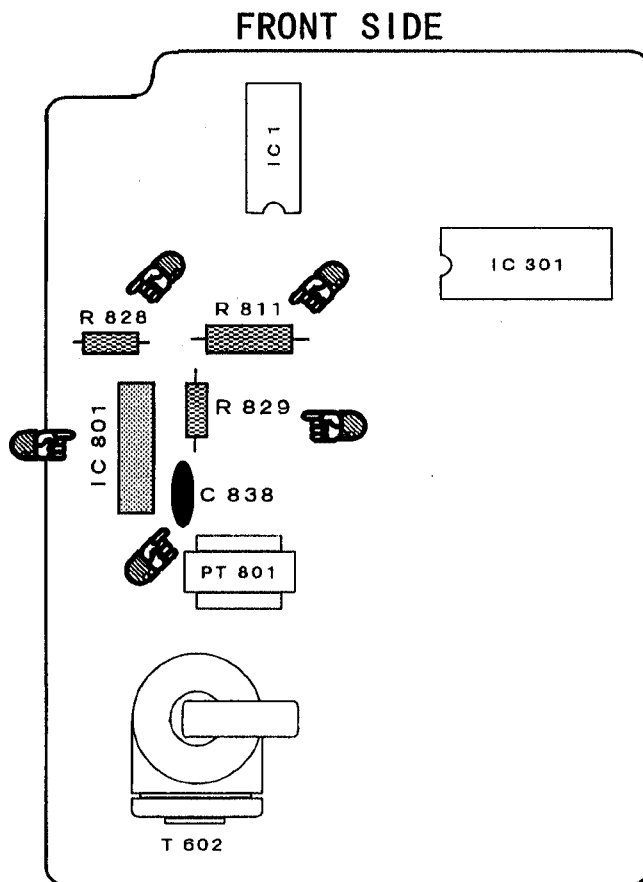
MODEL S : TV-A145, TV-A205, TV-A215
 SUBJECT : No power is turned on.
 DESCRIPTION : The power may not be turned on due to a fault of the ceramics capacitor (C838) on the power circuit. Regardless of the indicated phenomenon of faulty details, exchange the object capacitor (C838) with one of the specified type. If any peripheral part is damaged and the equipment cannot be operated at the same time, exchange the part with a new one.

- Specified capacitor: C838
 1000P • 1K K → 1000P • 1K K R

- When the equipment does not operate due to a faulty peripheral part, exchange the following parts with new ones.
 IC801, R811, R828, R829

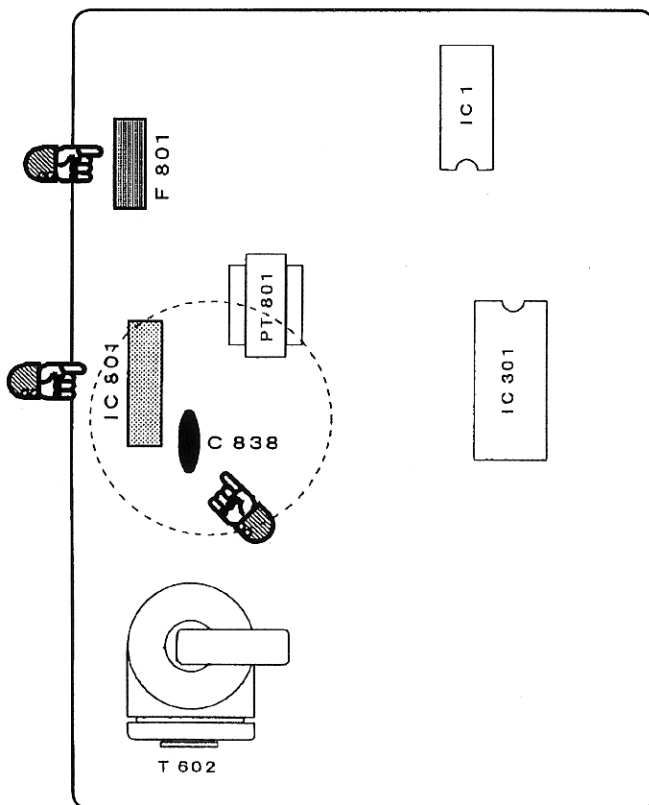
MODEL S : TV-C142, TV-C202
 SUBJECT : No power is turned on.
 DESCRIPTION : The power may not be turned on due to a faulty ceramics capacitor (C838) on the power circuit. Regardless of the indicated phenomenon of faulty details, exchange the undesirable capacitor (C838) with a one of the specified type. At the same time, if any peripheral part is damaged and the equipment cannot be operated, exchange the part with a new one.

- Specified capacitor: C838
 1000P • 1K K → 1000P • 1K K R
- When the equipment does not operate due to a faulty peripheral part, exchange the following parts with new ones.
 IC801, F801
- * The position of C838 is slightly different between boards with the end numbers 11 and 12. Therefore, take the following precautions on installation.

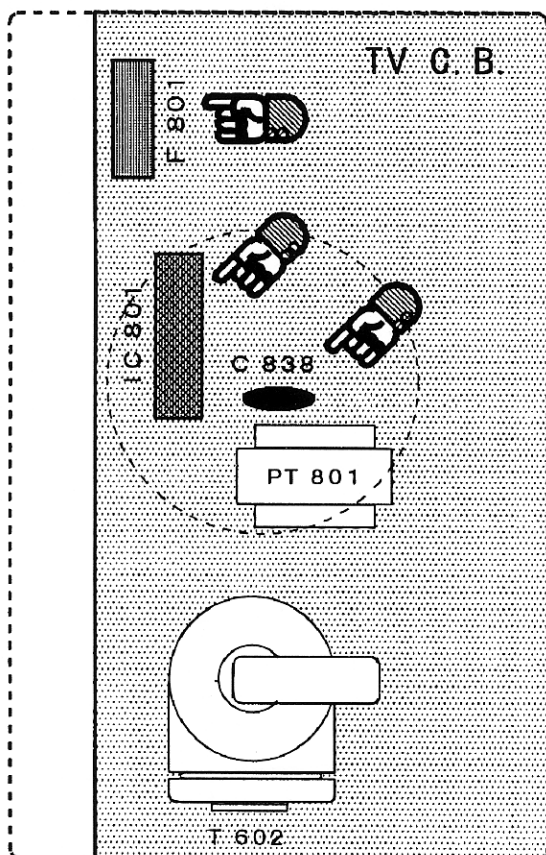
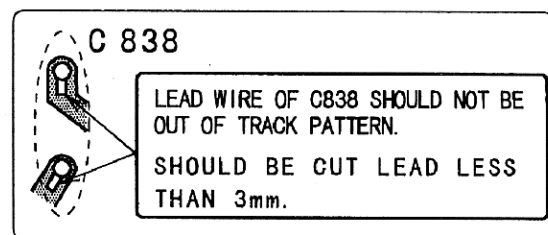
MODEL : TV-C2120 DH
 SUBJECT : No power is turned on.
 DESCRIPTION : The power may not be turned on due to a faulty ceramics capacitor (C838) on the power circuit. Regardless of the indicated phenomenon of faulty details, exchange the undesirable capacitor (C838) with a one of the specified type. At the same time, if any peripheral part is damaged and the equipment cannot be operated, exchange the part with a new one.

- Specified capacitor: C838
 1000P • 1K K → 1000P • 1K K R
- When the equipment does not operate due to a faulty peripheral part, exchange the following parts with new ones.
 IC801, F801
- During soldering, take great care to the following respects.

Ref.	Part Name	Part No.	Remarks
C838	CAP, CER 1000P-1K K R	87-A10-832-01/08	CHANGED FROM 87-016-515-080
IC801	IC, STR-S6707	87-A20-517-010	
F801	FUSE, 4A 250V T 218	87-035-458-010

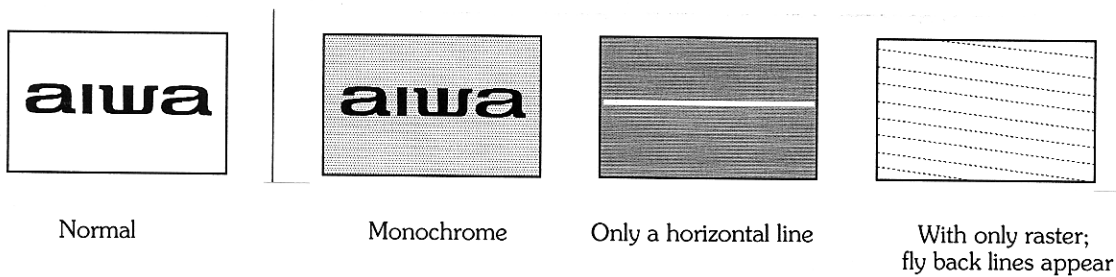
MODEL : TV-1452 NH
 SUBJECT : Abnormal screen display
 CONTENT : Electric discharge on the CRT may damage the CRT C. B transistor (2SC2482, 2SC1815Y) and the TV C. B IC201 (TA8825AN). In these cases, the following symptoms are present.
 *As electric discharge on the CRT seldom occurs, it is therefore not caused by a malfunction in the CRT.

REMEDY : Replace the damaged parts. Then, to prevent a repetition of those problems, follow steps (1- 5) for the circuit modification described below.
