# Sun Fire™ B1600 Chassis and B100s, B100x, and B200x Blade Product Notes

Part No. 817-5626-12  
May 2004, Revision A

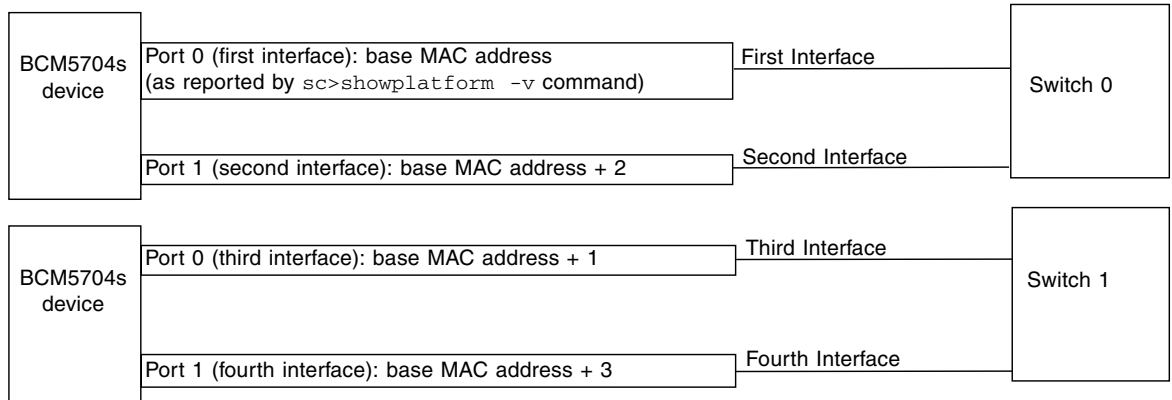
**FIGURE 3-1** The Network Interfaces on a B200x Blade

### *4877872: Difference Between the Network Interface Assignments Displayed by the BIOS, DCA, and Solaris x86 Software on a B200x*

The B200x blade has two dual-port BCM5704s Gigabit Ethernet chips. Each individual port is connected to one of the Ethernet switches in the B1600 chassis, and the BIOS takes responsibility for assigning the MAC addresses to the Ethernet ports (see FIGURE 3-1).
