KIT FEATURES

99-7892 INSTALLATION INSTRUCTIONS

APPLICATIONS

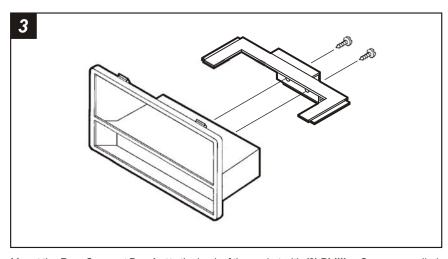
Mount the **Rear Support Bracket** to the back of the pocket with (2) **Phillips Screws** supplied. *Skip to the Installation Instructions for ALL VEHICLES on Page #11.*

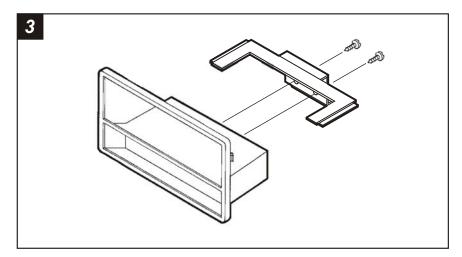
ISO-DIN HEAD UNITS: Mount the **Rear Support Bracket** to the back of the pocket with **(2) Phillips Screws** supplied. Skip to the Installation Instructions for ALL VEHICLES on Page #11.

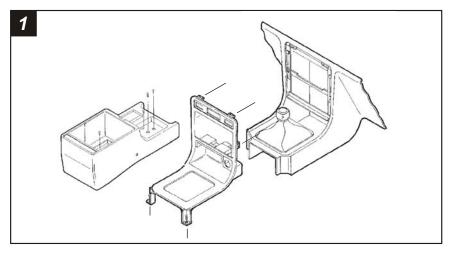
HONDA Accord 1994-97

Disconnect the negative battery terminal to prevent an accidental short circuit. Remove the ashtray and (1)³/"#8 Phillips screw exposed. Open the storage compartment and remove (2) #8 Phillips screws exposed. Remove the cupholder tray and (3)#8 Phillips screws inside. Lift the center console out and remove (2) Phillips screws exposed at the base of the dash trim bezel. Unclip the bezel and remove. Remove (2) hex-head screws securing the factory head unit and disconnect the wiring.

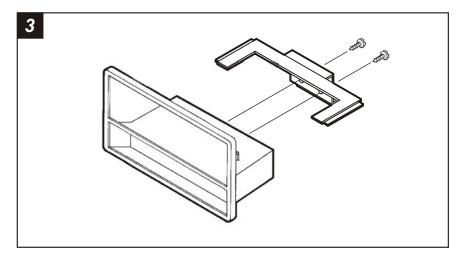
ISO-DIN HEAD UNITS: Mount the **Rear Support Bracket** to the back of the pocket with **(2) Phillips Screws** supplied. Skip to the Installation Instructions for ALL VEHICLES on Page #11.

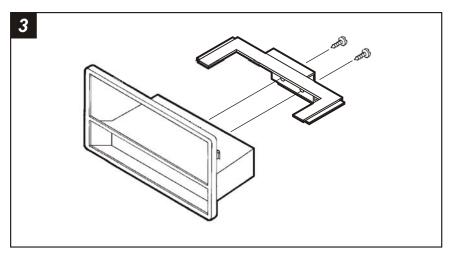
ISO-DIN HEAD UNITS: Mount the **Rear Support Bracket** to the back of the pocket with (2) **Phillips Screws** supplied. Skip to the Installation Instructions for ALL VEHICLES on Page #11.

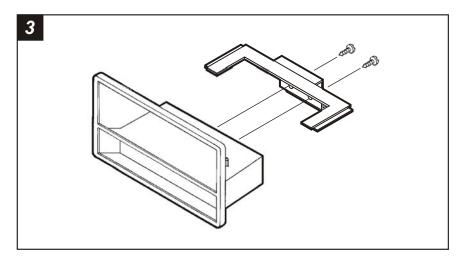
ISO-DIN HEAD UNITS: Mount the **Rear Support Bracket** to the back of the pocket with **(2) Phillips Screws** supplied. Skip to the Installation Instructions for ALL VEHICLES on Page #11.

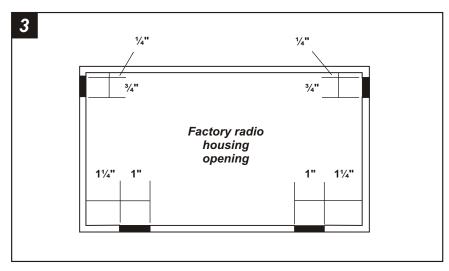
Modify the factory radio housing by trimming the *shaded* portions of the housing lip. *Skip to the Installation Instructions for ALL VEHICLES on Page* #11.

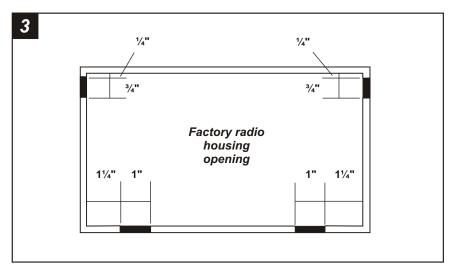
Modify the factory radio housing by trimming the *shaded* portions of the housing lip. *Skip to the Installation Instructions for ALL VEHICLES on Page* #11.

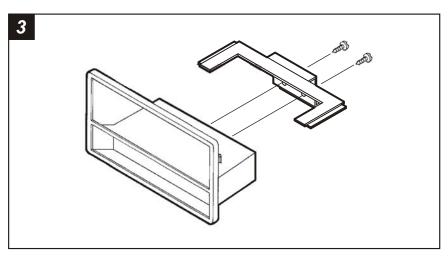
ISO-DIN HEAD UNITS: Mount the **Rear Support Bracket** to the back of the pocket with (2) **Phillips Screws** supplied. Skip to the Installation Instructions for ALL VEHICLES on Page #11.

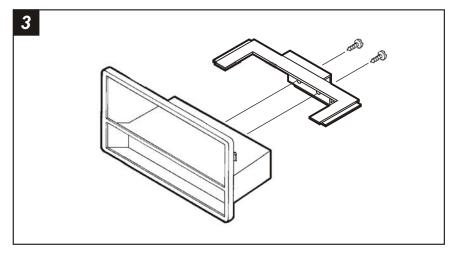
ISO-DIN HEAD UNITS: Mount the **Rear Support Bracket** to the back of the pocket with **(2) Phillips Screws** supplied. Skip to the Installation Instructions for ALL VEHICLES on Page #11.
