TECHNICAL DOCUMENT

Disassembly Instructions

Lexmark E-321/E323 Toner Cartridge

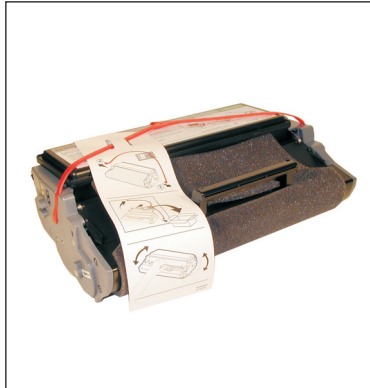
These cartridges come new with a shipping lock/foam combination. The shipping lock and foam are unique to the E320/321 series of cartridges. See Figure 1

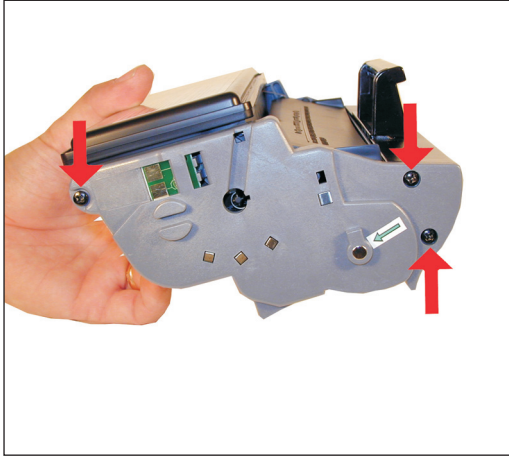
1) On the left side of the cartridge (Chip Side) remove the 3 screws. See Figure 2

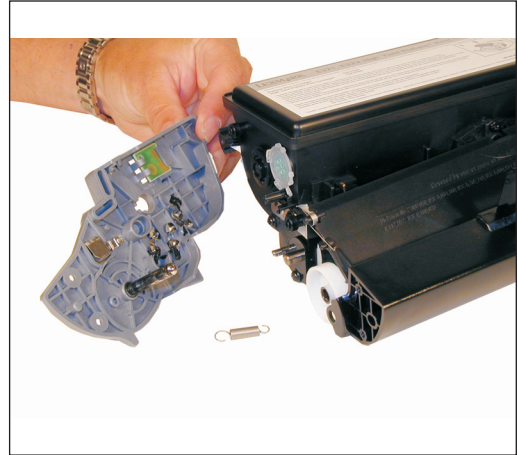
2) Carefully remove the end cap. Note that a spring will come loose and the cartridge will basically fall apart at this point. If you intend to re-use the drum, make sure you are very careful not to damage it. See Figure 3

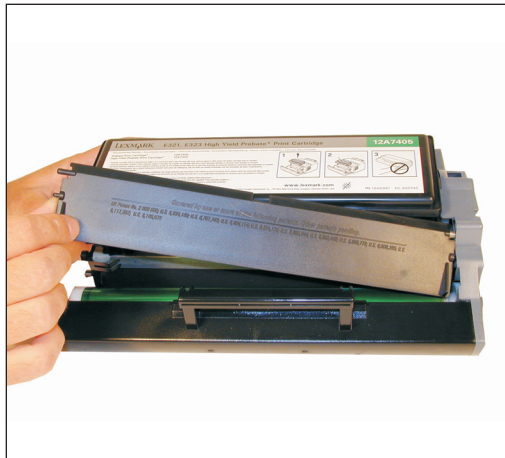
3) Remove the drum cover. Note the position of the springs. See Figure 4

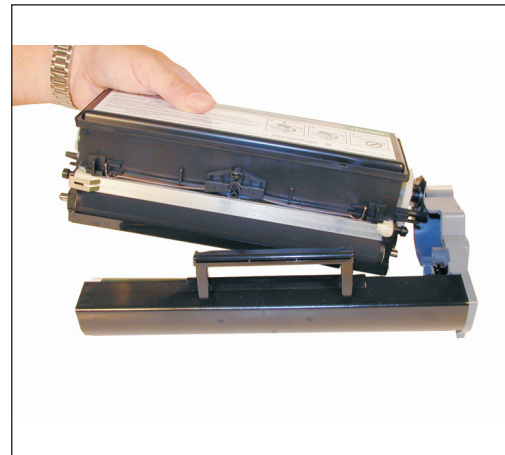
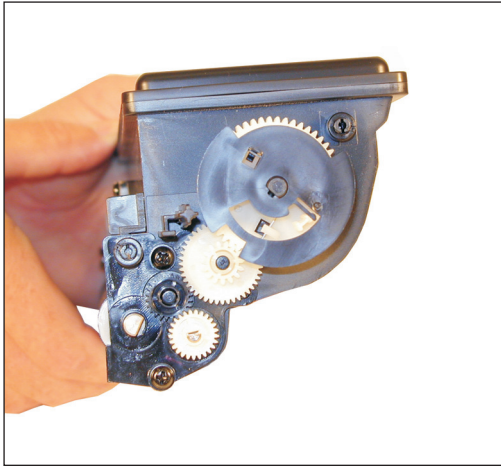
4) Remove the toner supply chamber (the second spring will come loose). Make sure that all the gears stay in place. The supply hopper spring will come off, be careful not to lose it. See Figure's 5 & 6 (on next page)

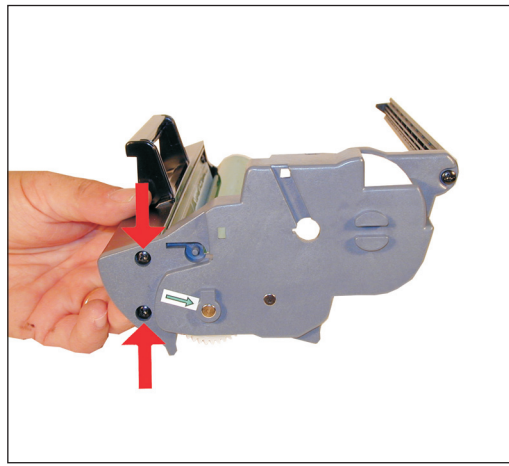
5) Remove the two front screws only from the right end cap. The back screw holds the long brace in place and does not need to be removed. See Figure 7

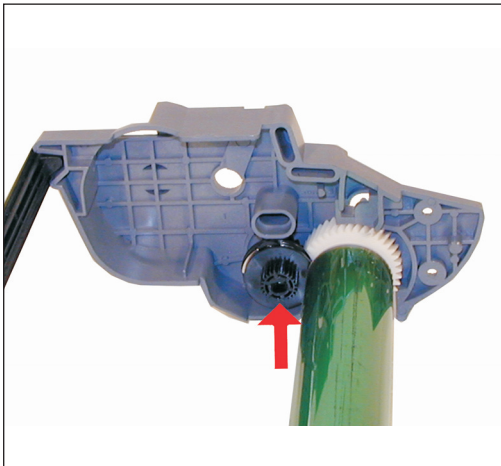
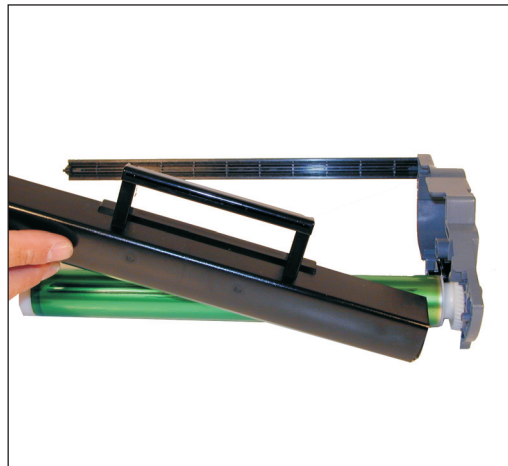
6) Remove the drum coupling gear (Smaller version of the 4039/4049). Remove the drum, remove the waste chamber. The waste chamber has to be the last to come out as there is a side piece from it that fits behind the drum. See Figure's 8 & 9

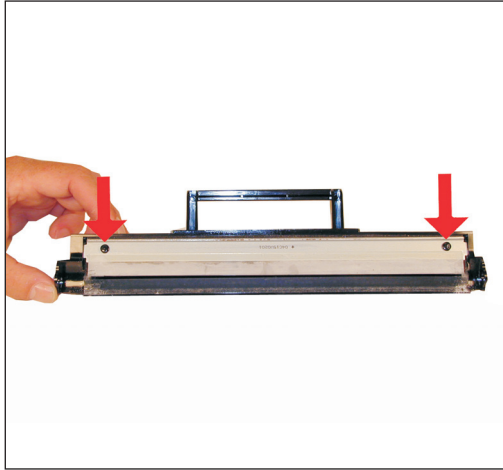
7) Remove the two screws on the wiper blade, and the blade. Clean out the waste chamber. The screws for the wiper blade are smaller than the end cap screws. See Figure 10

NOTE: Be very careful not to damage or distort the thin Mylar Recovery Blade next to the wiper blade. If this blade is bent or damaged in any way, it should be replaced.

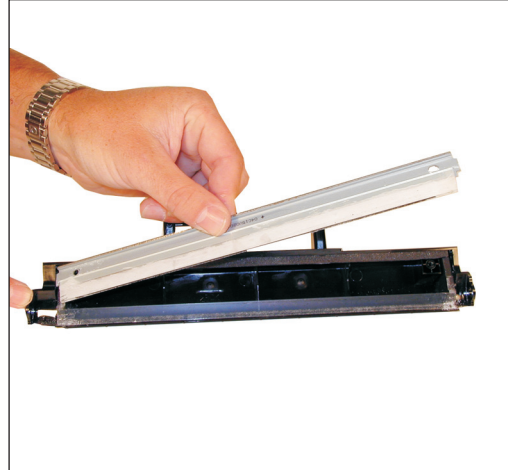
8) Coat the new wiper blade with your preferred lubricant, and install the wiper blade and two screws. Remember to use the smaller screws. See Figure 11

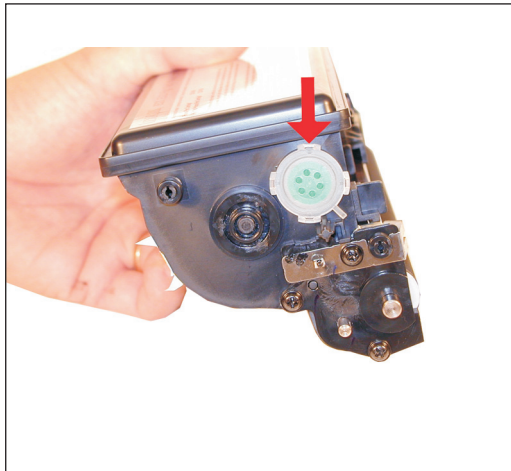
9) Remove the fill plug from the toner supply and dump/vacuum out the remaining toner. See Figure 12

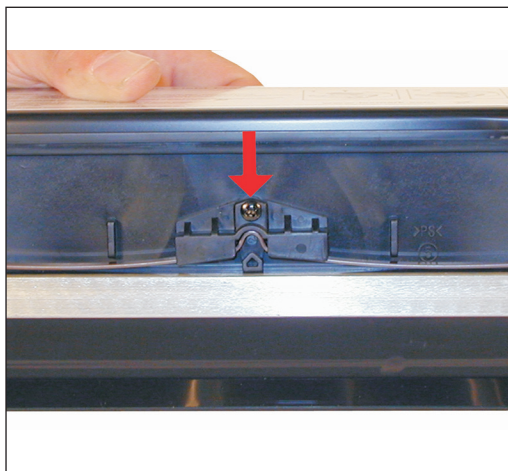
10) Remove the screw on the doctor blade spring holder. Remove the entire spring and holder assy. See Figure 13

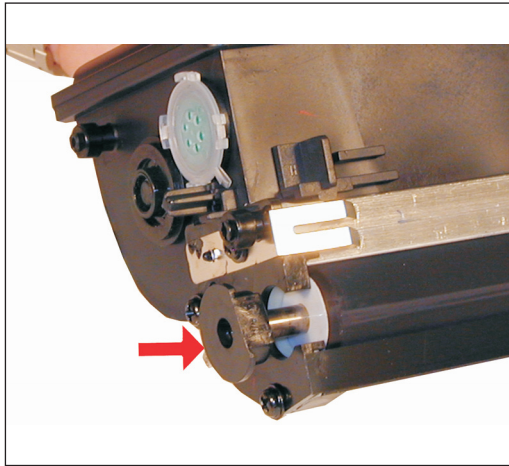
11) On the left side of the toner hopper (fill plug side), pry out the developer roller bushing. See Figure 14

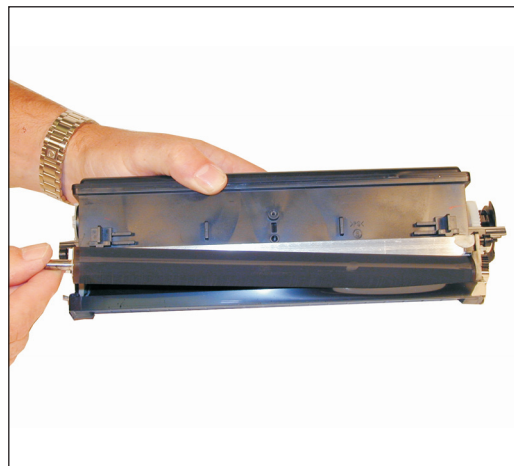
12) Remove the developer roller. Be careful not to damage the black retaining blade. See Figure 15

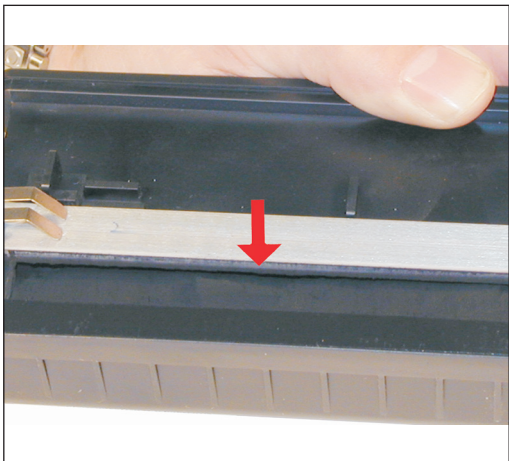
13) Clean the working edge of the doctor blade with a Scotch-Brite pad and alcohol. See Figure 16

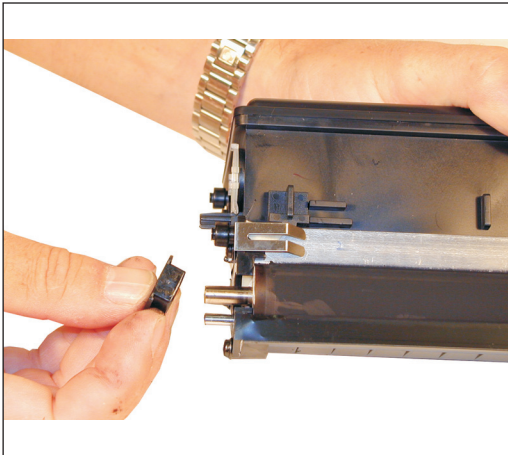
NOTE: The shims on the developer roller are similar to those used on the 4019/39/49 cartridges. The same replacement shims can be used if they become damaged.

14) Replace the developer roller back into the hopper. Make sure that the shims are not damaged, and that the black retaining blade is not damaged. Install the bushing. See Figure 17

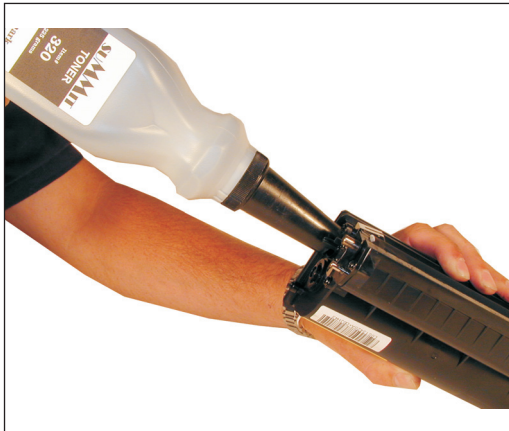
15) Fill the hopper with 225g of E320 toner. Replace the fill plug. See Figure 18

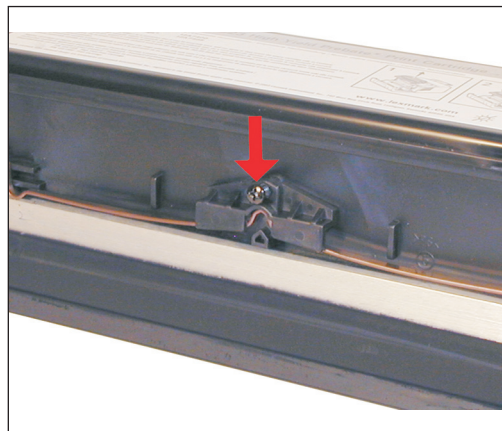
16) Install the doctor blade spring holder, spring and screw. See Figure 19

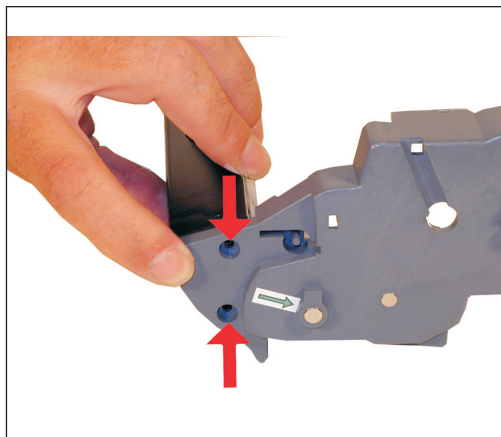
17) Install the waste chamber into the right end cap. Install the 2 screws. See Figure 20

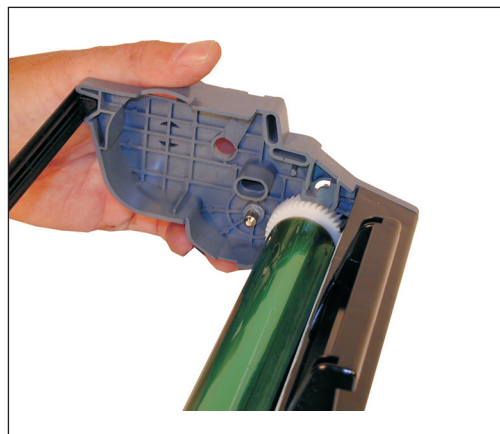
18) Install the drum (gear side) into the right end cap. See Figure 21

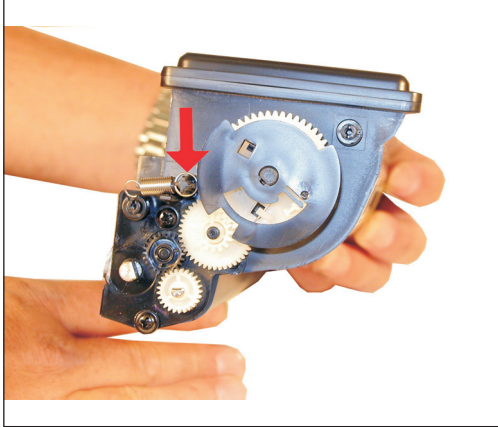
19) Install the spring large loop side on the large toner hopper post. See Figure 22

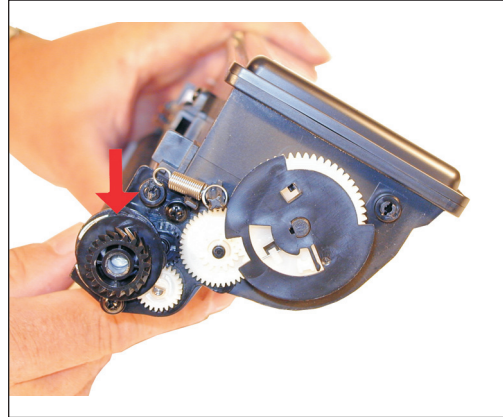
20) Install the coupler gear on to the shaft on the toner supply. Note that the gear and shaft are both keyed. See Figure 23

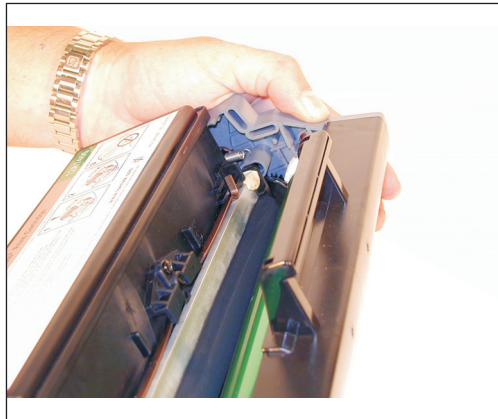
21) Install the toner supply hopper into the end cap. See Figure 24

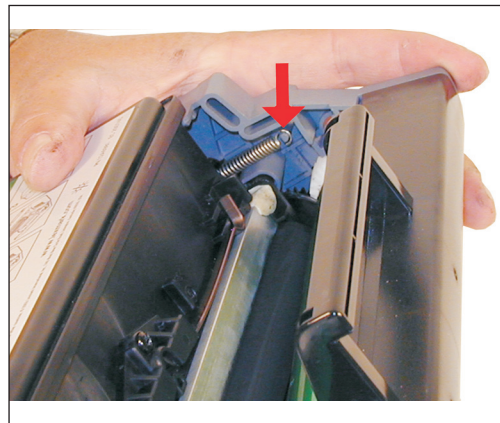
22) While holding the supply hopper in place, take the spring hook, grasp the small loop of the spring and place it on the small end cap post. See Figure 25

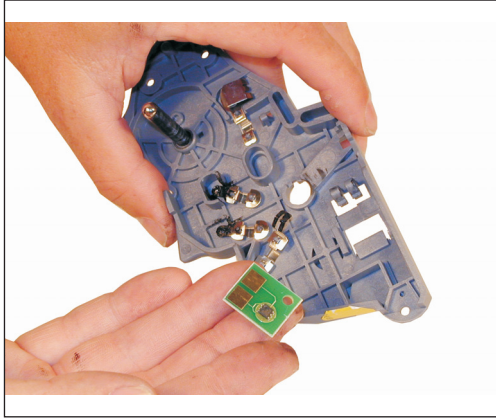
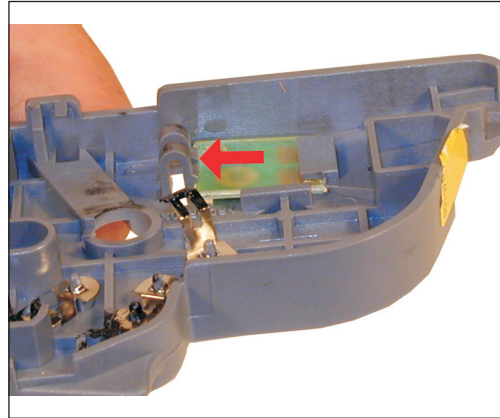
23) If you have a Prebate cartridge, install the replacement chip in the left end cap. Make sure that the chip is locked in place by the two plastic tabs. See Figure's 26 & 27

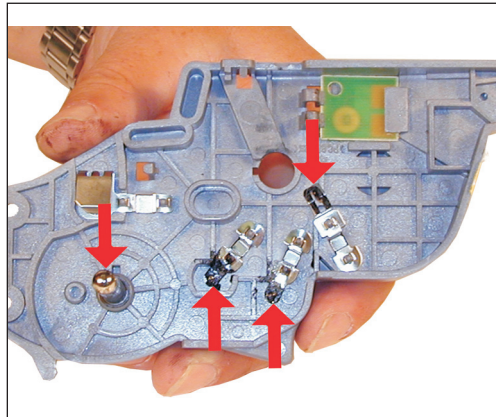
24) Clean off all the old conductive grease from the left end cap. Reapply new grease to all the contact points including a small amount on the drum axle shaft. Remember, when using conductive grease, more is not better. Just use a small amount on each point. See Figure 28

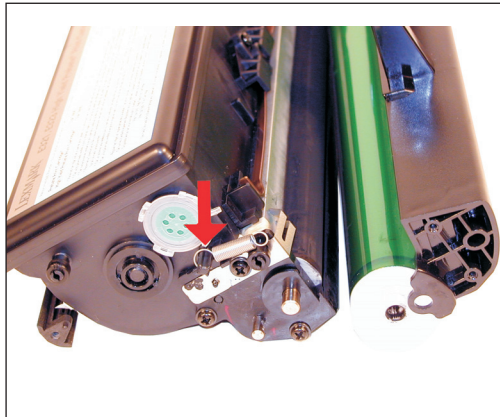
25) Place the large loop of the second spring on the large hopper post. See Figure 29

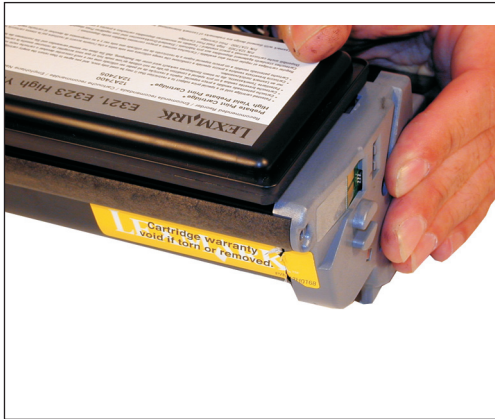
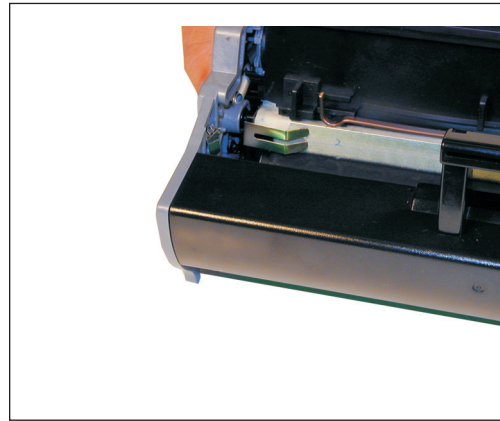
26) Carefully align and install the left end cap. Make sure the back brace fits correctly and that the alignment pins are all in their correct position. Snap the end cap in place. See Figure's 30 & 31

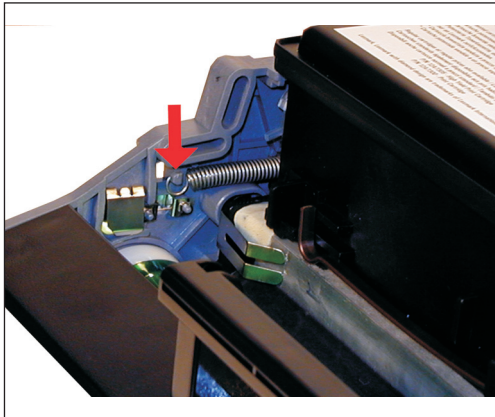
27) With the spring hook, grasp the small loop of the spring and place it on the small end cap post. See Figure 32

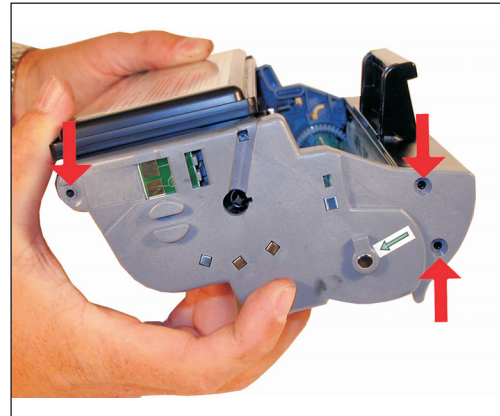
28) Install the three screws on the end cap. See Figure 33

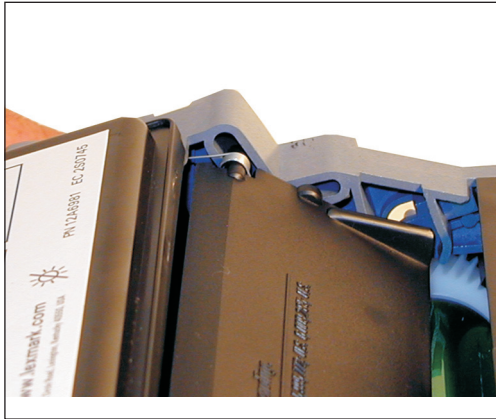
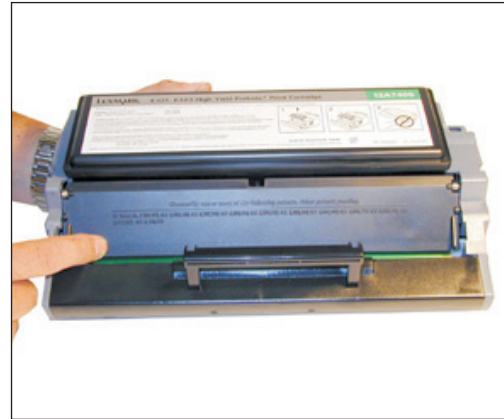
29) With the springs in the correct position, bend the drum cover slightly in the middle. Place the alignment pins in their respective slots. Try to make sure the large tail of the spring fits in place as you fit the cover in place. See Figure's 34 & 35
