TMS320C6201
Digital Signal Processor
Silicon Errata

SPRZ153
November 2000

This document describes the silicon updates to the functional specifications for the TMS320C6201 silicon releases 3.1, 3.0, 2.1, and 2.0.

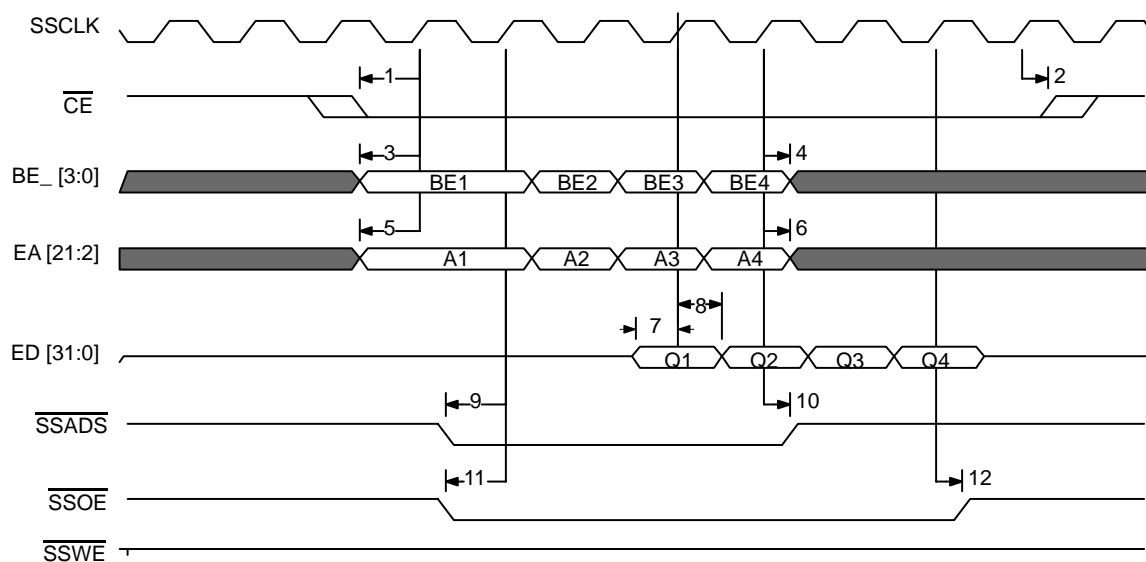
Figure 2. SBSRAM Read Timing (1/2 Rate SSCLK) (See Note)

NOTE: The $\overline{\text{CE}}$ output setup and hold times are specified to be accurate relative to the clock cycle to which they are referenced, since these timings are specified as minimums. However, the $\overline{\text{CE}}$ output setup and hold time may be greater than that shown in the data sheet in multiples of P ns. In other words, for output setup time, the $\overline{\text{CE}}$ transition from high to low may happen P, 2P, ..., or nP ns before the time specified by the data sheet. Similarly, for output hold time, the $\overline{\text{CE}}$ low-to-high transition may happen P, 2P, ..., or nP ns after the time specified by the data sheet. This is indicated by the period of uncertainty for specs 1 and 2 in Figure 2, and Figure 3.

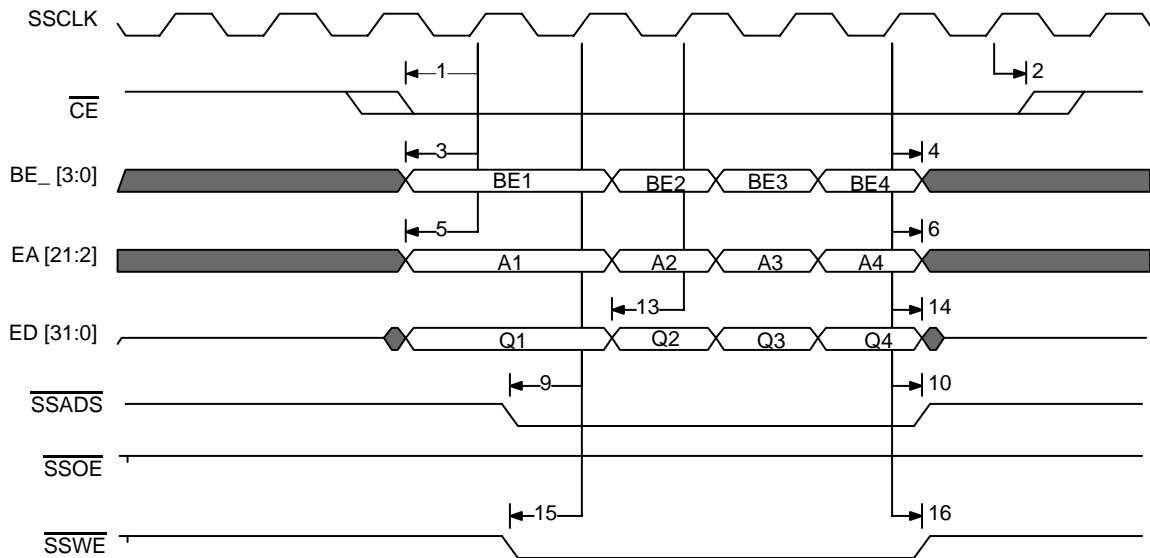
Figure 3. SBSRAM Write Timing (1/2 Rate SSCLK) (See Note)

NOTE: The $\overline{\text{CE}}$ output setup and hold times are specified to be accurate relative to the clock cycle to which they are referenced, since these timings are specified as minimums. However, the $\overline{\text{CE}}$ output setup and hold time may be greater than that shown in the data sheet in multiples of P ns. In other words, for output setup time, the $\overline{\text{CE}}$ transition from high to low may happen P, 2P, ..., or nP ns before the time specified by the data sheet. Similarly, for output hold time, the $\overline{\text{CE}}$ low-to-high transition may happen P, 2P, ..., or nP ns after the time specified by the data sheet. This is indicated by the period of uncertainty for specs 1 and 2 in Figure 2, and Figure 3.
