*MJ-1101 Service Manual Addendum*  
Supplement to the Troubleshooting Section

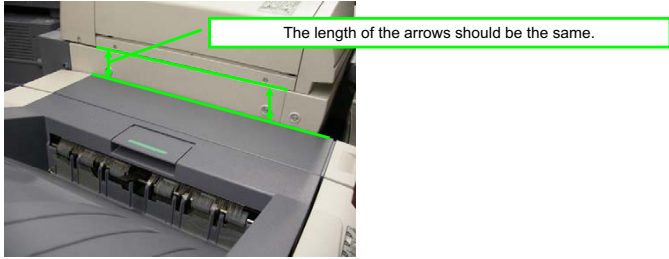
Error code	Phenomenon	Possible cause	Items to confirm / Countermeasures	Precautions / Remarks
EA20	<ul style="list-style-type: none"> <li>- Paper jams at the entrance section of the Finisher (or the Hole Punch Unit)</li> <li>- Folded paper edge</li> <li>- Paper jams C2in the buffer tray section</li> <li>- C2Paper exit problems on the finishing tray</li> </ul>	<p>1. Improper installation height (Paper is not properly transported from the equipment to the Finisher if each height is improper.)</p>	<p>A. Confirm that the Finisher is installed horizontally (the height of its front side and that of its rear side are the same).</p>

<ul style="list-style-type: none"> <li>- Note that the height should be different between the cases when the Finisher is installed in e-STUDIO281c/351c/451c and when installed in e-STUDIO352/452 or e-STUDIO2500c/3500c/3510c.</li> <li>- Confirm the height every time you move the equipment.</li> </ul>

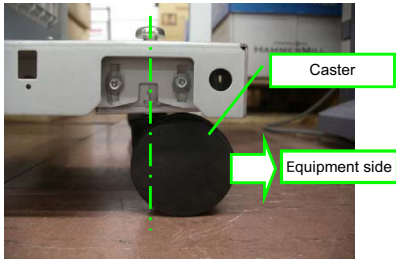
<p>B. To keep the installation height of the Finisher stable, it is preferable that the casters are faced to the equipment side.</p>

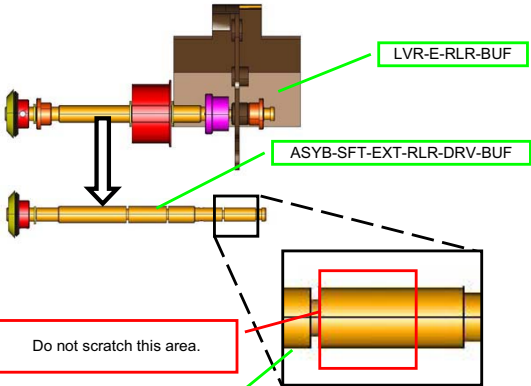
<p>B. Check if the gear teeth of GEAR-IDLER-EXT-BUF, GEAR1-EXT-RLR-BUF and GEAR2-EXT-RLR-BUF mesh correctly. If any of them does not mesh correctly, replace ASYB-SFT-EXT-RLR-DRV-BUF, ASYS-LVR-E-RLR-BUF, GEAR-IDLER-EXT-BUF, GEAR1-EXT-RLR-BUF or GEAR2-EXT-RLR-BUF.</p>

<p>When replacing, be sure not to scratch the shaft (ASYB-SFT-EXT-RLR-DRV-BUF).</p>
