IMPORTANT PRODUCT INFORMATION

Product: IC693CPU364 CPU Module with Ethernet Interface

IC693CPU364-AC with Firmware Release 9.10

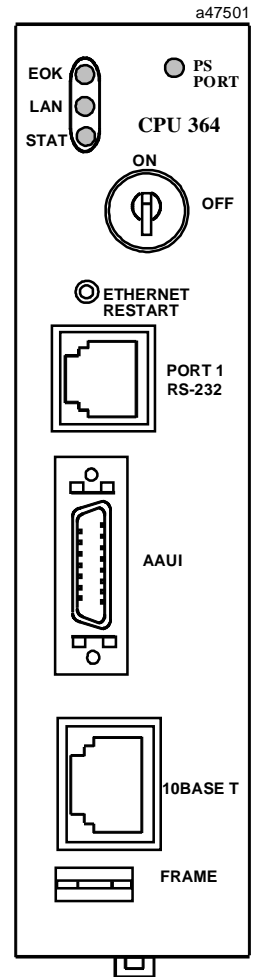
Note: On some modules the LED labeled "PS PORT" may say "SNP" instead; otherwise, the modules are identical.
