FRONT ANTI-TIPPERS MODEL NOS. 2226 AND 1326

Installation, Assembly and Operating Instructions

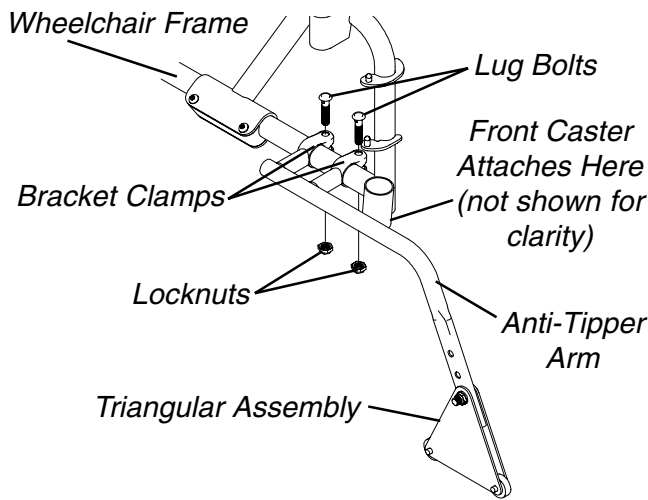
FIGURE 1 - INSTALLING FRONT ANTI-TIPPERS

1. Remove the locknuts and the lug bolts from the anti-tipper bracket clamps.
2. Position the anti-tipper bracket clamp over the wheelchair frame behind the front caster as shown in **FIGURE 1**.

*NOTE: Position the anti-tipper arm on the outside of the wheelchair as shown in **FIGURE 1**.*

3. Squeeze bracket clamps together and insert the bolts.
4. Install the locknuts onto the lug bolts. Tighten securely.
5. Repeat **STEPS 1-4** on the opposite side of the wheelchair for the remaining anti-tipper.
6. Measure from the floor to the bottom of the wheels of the triangular assembly.
7. Perform one (1) of the following:

NOTE: Right side Front Anti-Tipper pictured.

INSTALLING FRONT ANTI-TIPPERS (FIGURE 1)

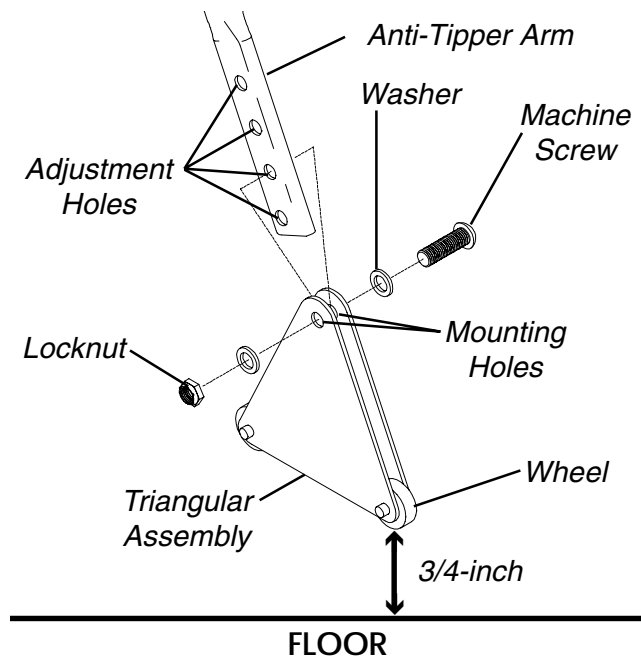
FIGURE 2 - ADJUSTING FRONT ANTI-TIPPERS

3. Remove the machine screw, washers and locknut securing the triangular assembly to the bottom of the anti-tipper arm.
4. Position the triangular assembly mounting hole to align with one (1) of the adjustment holes in the anti-tipper arm.
5. Measure from the floor to the bottom of the wheels of the triangular assembly.

6. Repeat **STEPS 4-5** until the bottom of the wheels of the triangular assembly measure approximately 3/4-inch from the floor.
7. Secure the triangular assembly to the bottom of the anti-tipper arm with the machine screw, washers and locknut.

8. Tighten the locknut until the triangular assembly does not rattle, but swings freely at the end of the anti-tipper arm.
9. Repeat **STEPS 1-2** for the opposite triangular assembly.

ADJUSTING FRONT ANTI-TIPPERS (FIGURE 2)
