OVERVIEW:

The PRV-LX1 is a professional-level DVD recorder designed to provide many hours of video recording and playback performance. While every operating environment is unique, there are some general maintenance practices you can follow to keep your PRV-LX1 running at optimal performance.

This document offers some general guidelines and maintenance recommendations for the PRV-LX1.

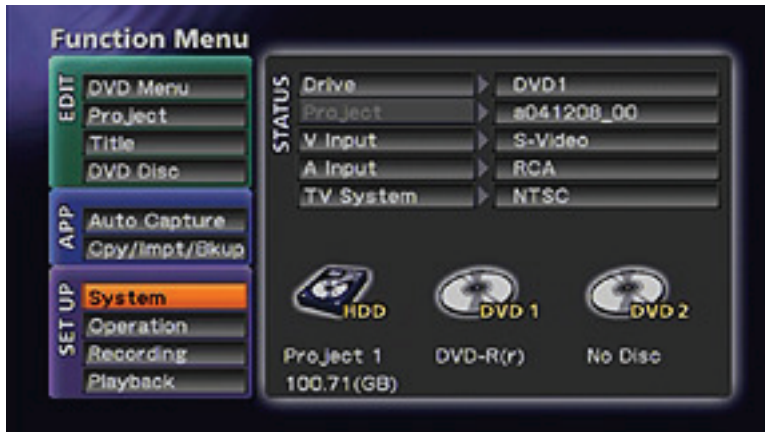
2. Scroll down to the **Setup** menu using the arrow buttons.
The first option, System, is highlighted.

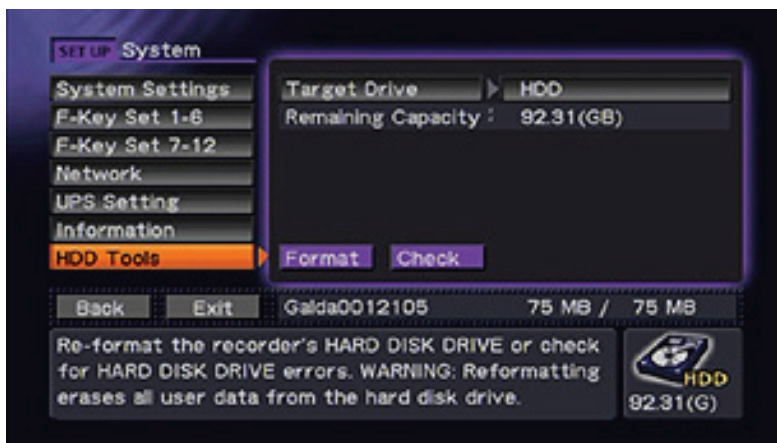
3. Press **Enter** to access the System submenu.
4. Scroll down to highlight **HDD Tools**.
