GREENHECK Supplement for Model TCB with UL-762

Installation Operation and Maintenance Manual Supplement for UL-762 Listed (Restaurant Exhaust) Fans

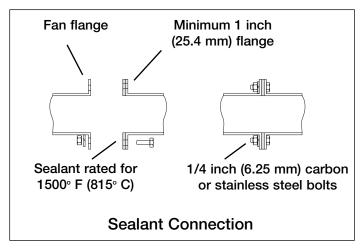
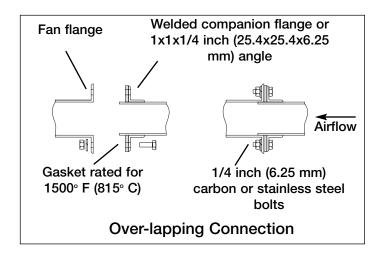
Inline fans shall be connected to the exhaust duct by flanges securely bolted as shown in the figures below (NFPA 96). Flexible connectors shall not be used. Units supplied with matching companion flanges are to have this part welded to the ductwork and then bolted to the fan. Gaskets used in the Over-lapping Connection style shall not be positioned in a manner to have direct contact with the grease.

Repair or replace sealant / gasket as needed. Replacement sealant or gasket shall be rated for 1500° F (815° C) and shall be grease tight such as 3M Fire Barrier 2000+ Silicone Sealant. See Sealant and Over-lapping Connection figures for proper installation.
